Historic Bridge Management Plan for the Mississippi River (Sunshine) Bridge

Recall Number: 203760

**Mead
& Hunt**

March 2017

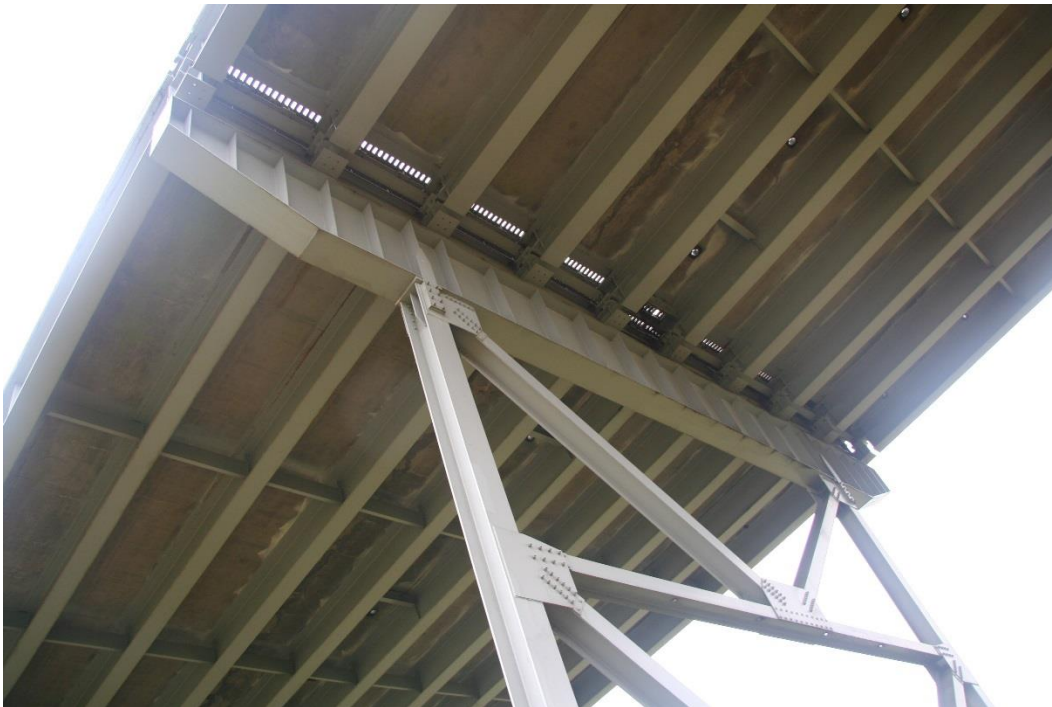
Condition Photo 4: Westerly approach spans with finger-type deck expansion joint at Bent 20.

1. Install collection troughs under finger-type expansion joints in the bridge decks, to direct water and debris away from the structural steel members and bearings below.
2. Remove and replace bridge deck expansion joint at west abutment for full width of bridge.
3. Mill and overlay asphalt overlay on concrete roadway approaches at each end of the bridge (existing asphalt overlay is severely deteriorated and in poor condition).

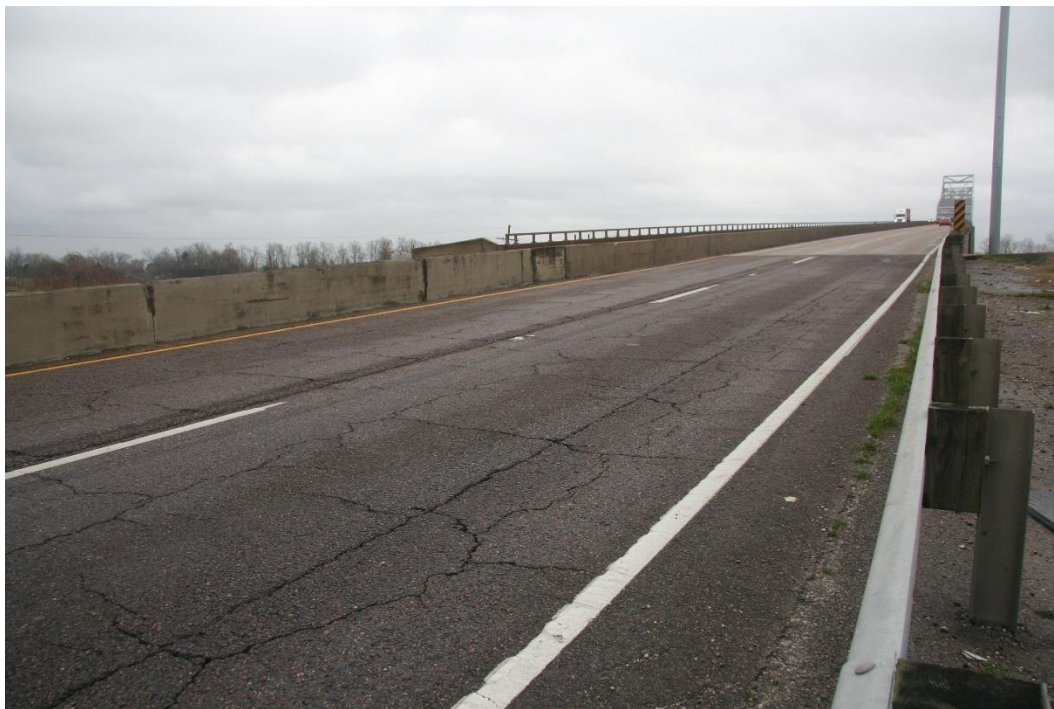
The condition of the asphalt overlay on the roadway approaches to the bridge at both the east and west ends is poor, with rutting, spalling, and cracking. According to the March 2016 bridge inspection report, navigation lights are functioning properly and are in good condition, except for one pedestal at the center of truss joint U32 that has heavy corrosion and section loss of the

Condition Photo 6: Eastbound approach roadway at west end of bridge.

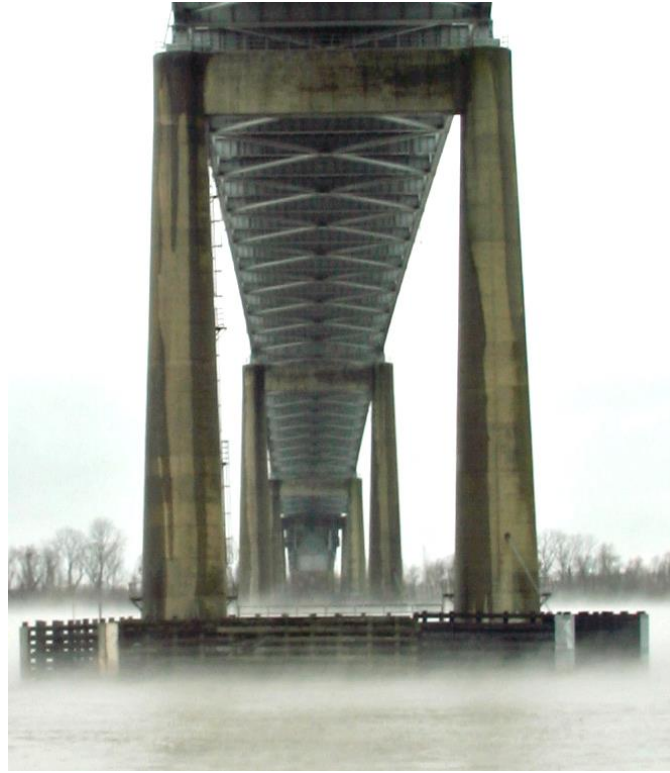
pedestal. The timber fender system for Piers 4 and 5 were rehabilitated in 2014 and are in good condition. The March 2016 bridge inspection report notes that there are decayed timbers in the timber fender system for Pier 3.

Condition Photo 13: Fender protection system at Pier 5.

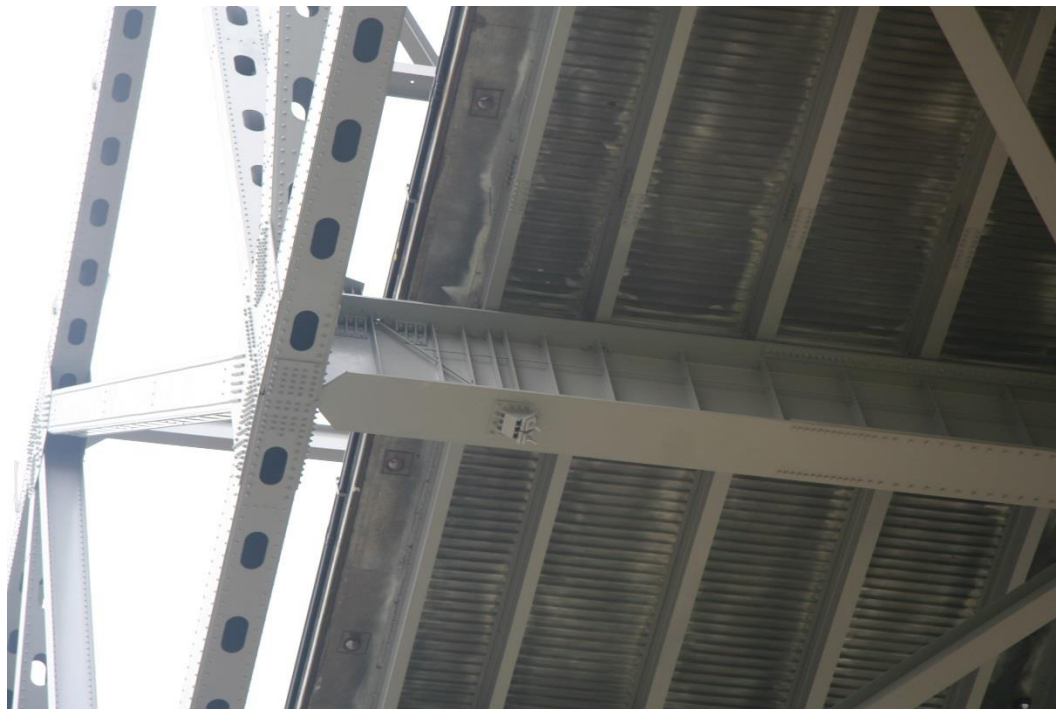
Condition Photo 14: Underside of truss span showing floor beams, stringers and deck system.

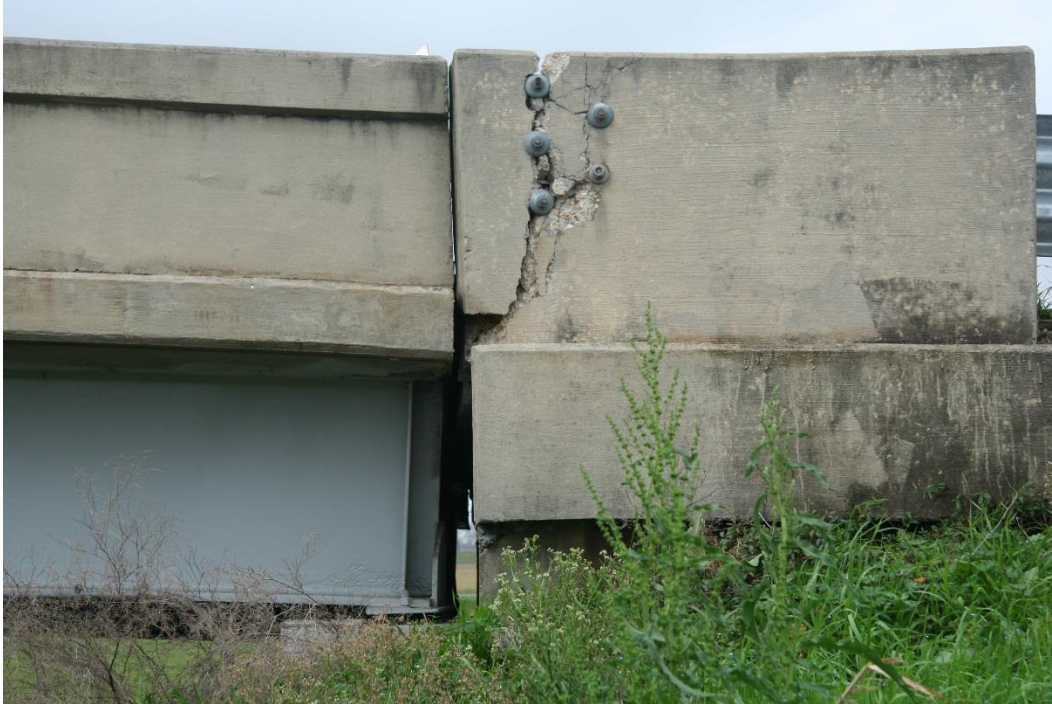
Condition Photo 17: Damaged barrier railing attachment at end of northerly Y-ramp

1. Repair the damaged concrete barrier at the metal guardrail attachment at the north end of the northerly Y-ramp at the east end of the bridge.

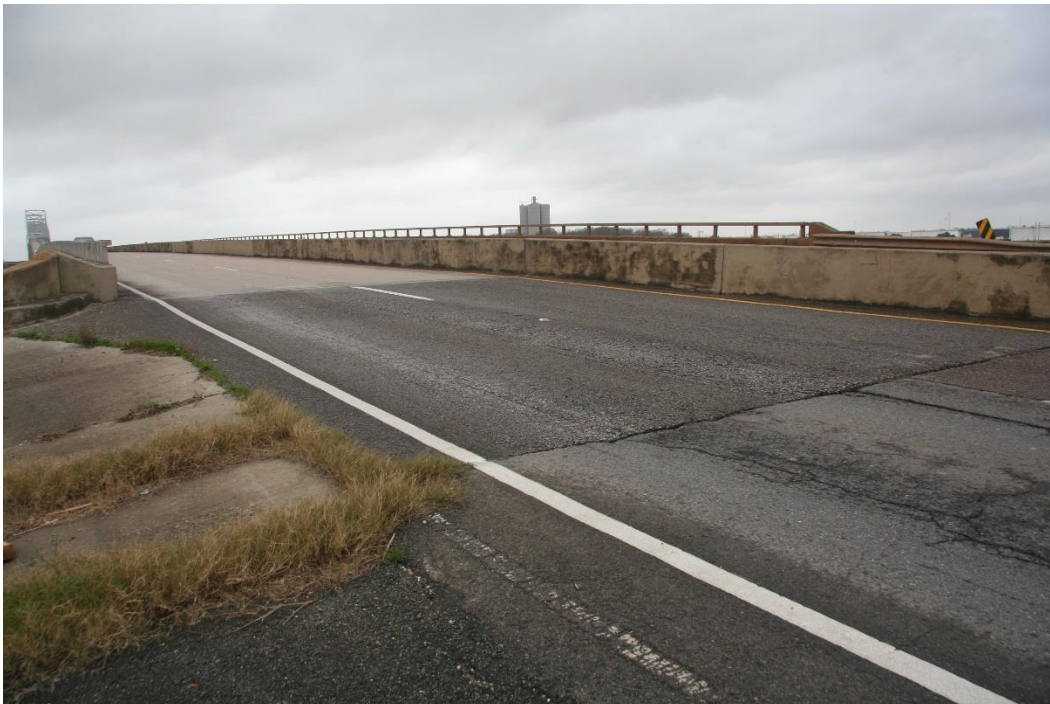
Condition Photo 20: Approach roadway at east end of eastbound roadway.

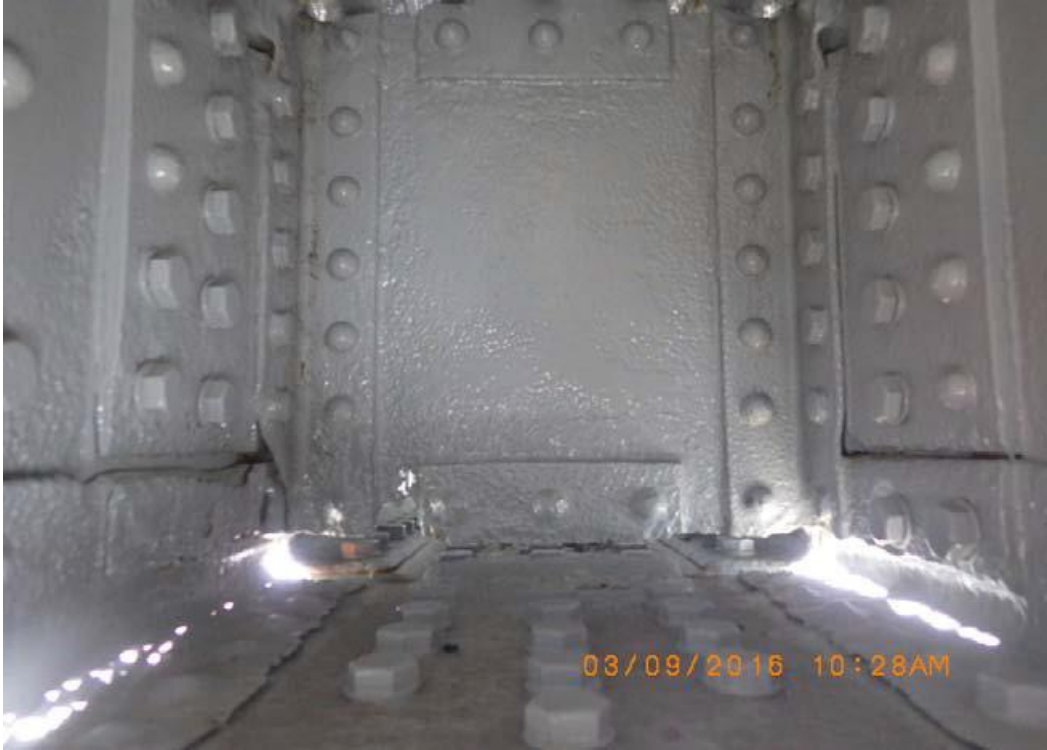
Condition Photo 21: View of heavy section loss to the inside of the lower chord at joint L19. Photo courtesy of the LADOTD from inspection performed March 7, 2016.

As noted previously, additional structural repairs are planned for the truss spans and approach spans of this bridge. Since plans for repairs are underway, structural steel repairs to truss and approach spans are not included in the recommendations or cost estimates for this plan.

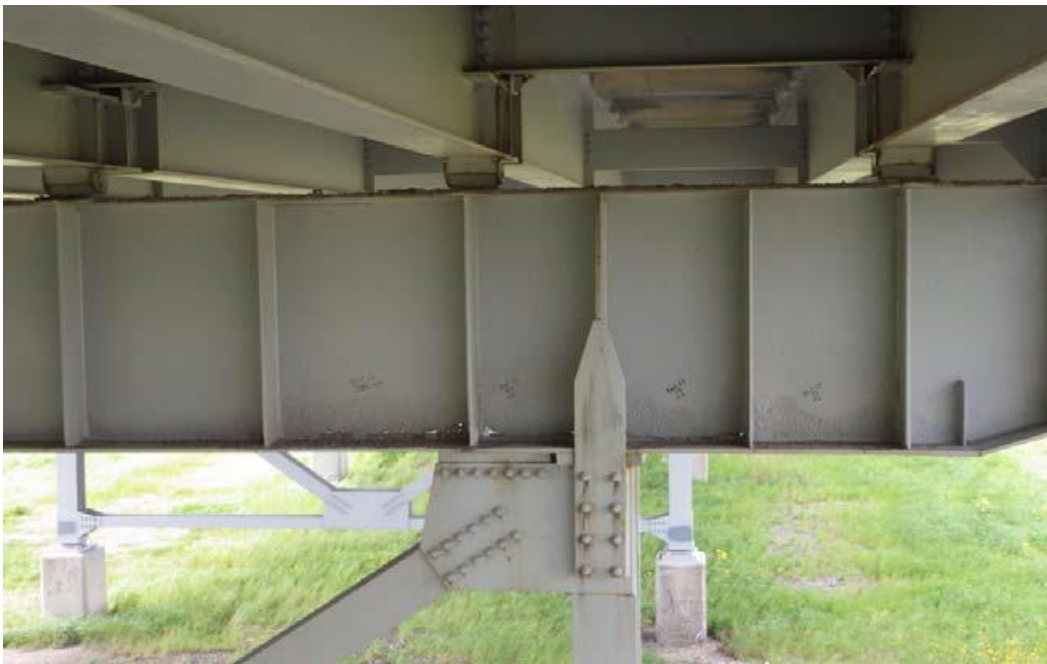
All steel bents have fracture critical cap beams. The condition of the structural steel is fair. Additional deterioration in some structural steel members, particularly the steel cap beams, was revealed following the 2012-2016 rehabilitation work. The concrete foundations for the bents are in good condition.

Condition Photo 22: Bent 54 cap has 100% section loss in web, which is typical for bent top girder; rust stains noted to the tops of the floorbeams. Photo courtesy of the LADOTD from inspection performed March 7, 2016.

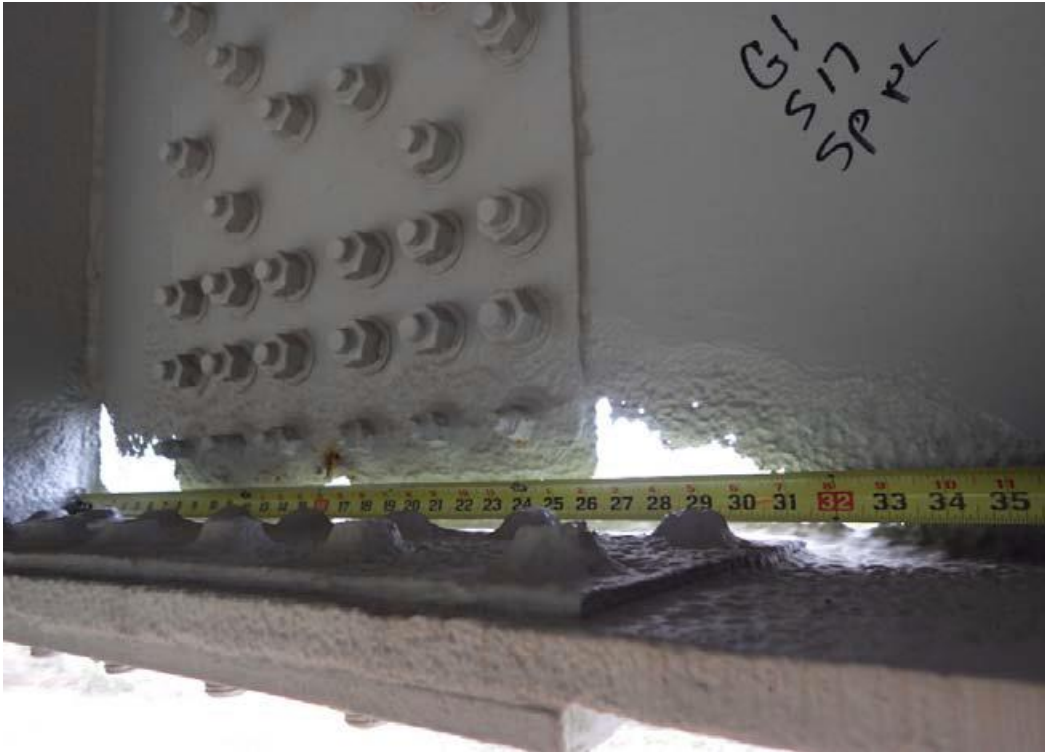
Condition Photo 23: West approach span 17, girder 1 has 100% section loss in the web near bottom flange at the splice plate. Photo courtesy of the LADOTD from inspection performed March 7, 2016.

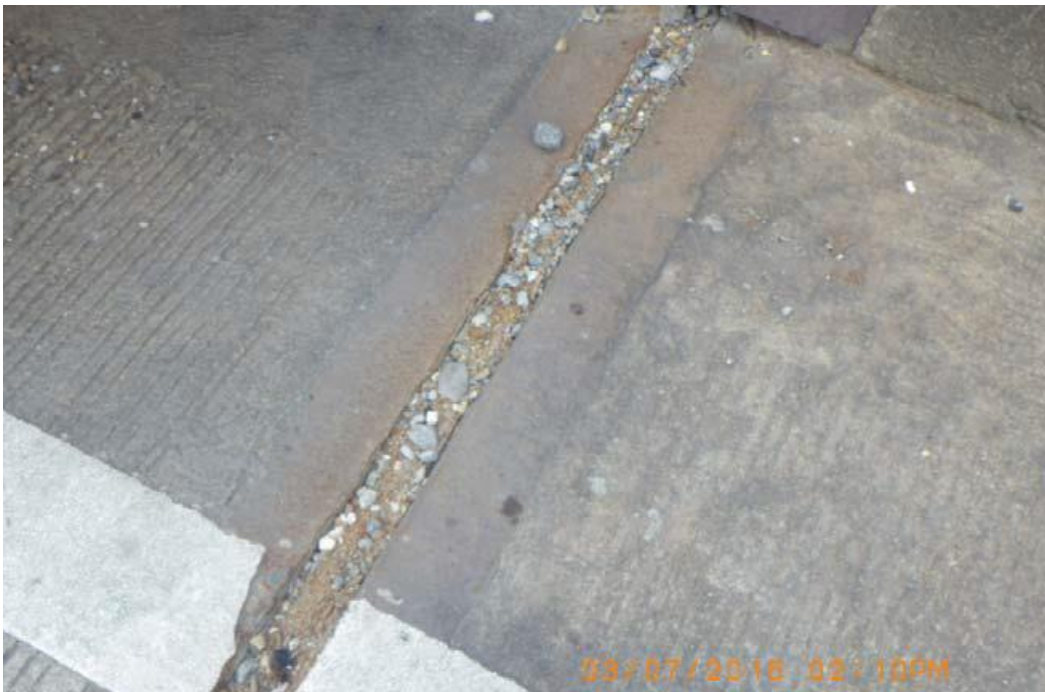
Condition Photo 24: Compression seals have a heavy accumulation of rocks and debris throughout the structure. Photo courtesy of the LADOTD from inspection performed March 7, 2016.
