Final Report 650

Load Rating of Existing Continuous Stringers on Louisiana's Bridges

C. Shawn Sun
Louisiana Tech University

Daniel G. Linzell
Jay A. Puckett
University of Nebraska-Lincoln

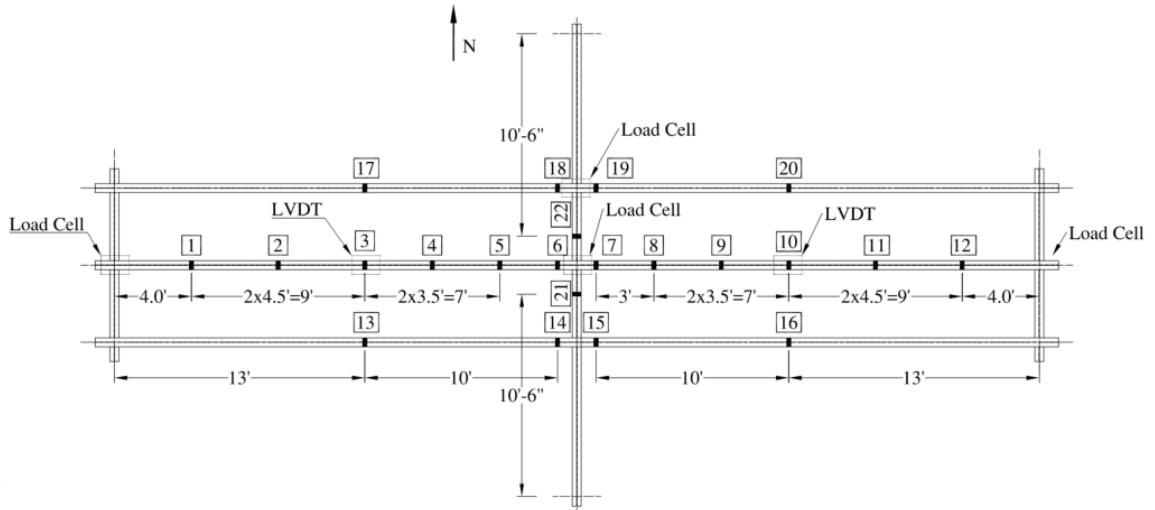
Figure 30. Instrumentation plan view

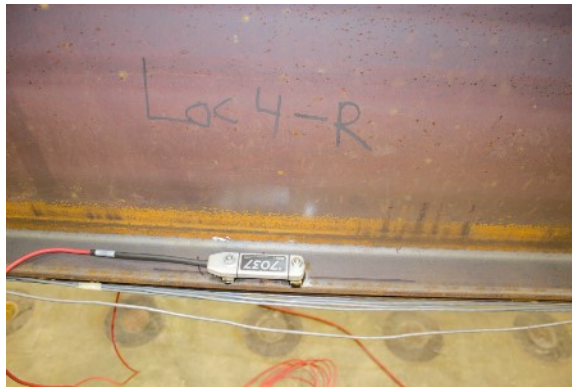
Figure 33. Strain gauge, Loc. 4

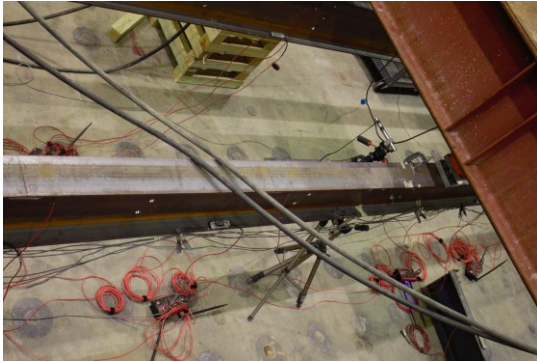
Figure 34. Test Run #3

(a) Midspan LVDTs and load cell

As indicated in Table 17, Group I tests were of the grillage system with no intermediate stringer bracing. Figure 34 depicts Test Run #3, showing vertical and lateral LVDTs on the interior stringer, the applied load and corresponding load cell at midspan, a supported (stiff) floor beam, and the bolted connection between the interior stringer and floor beam. Figure 35 shows LTB of the interior stringer observed during the test.

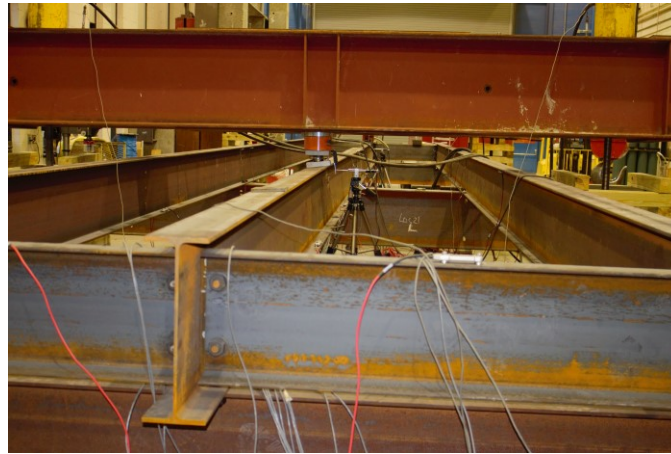
Figure 35. LTB of the interior stringer, Test Run #3

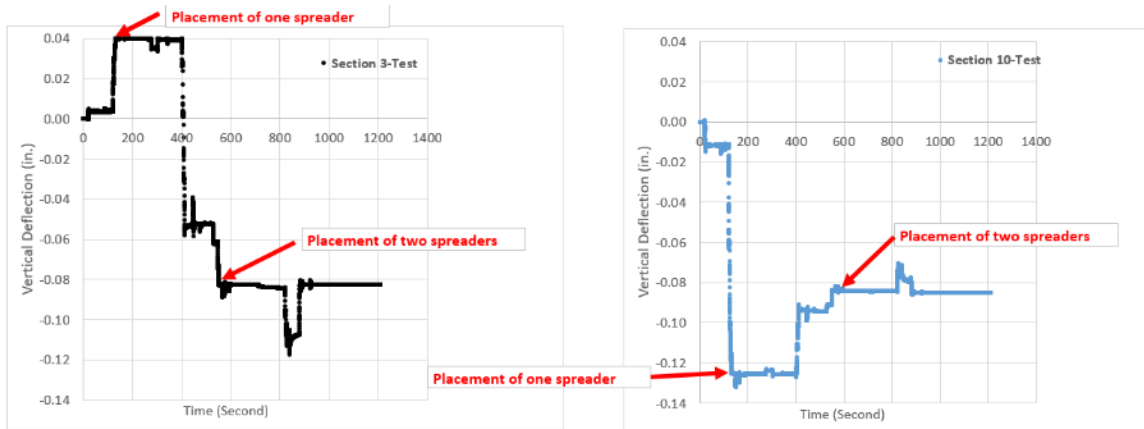
Figure 36. Vertical deflections from placement of spreaders at Locs. 3 and 10

Prior to applying load testing it was of importance to establish initial conditions caused by placement of the spreader beams onto the grillage. Each spreader beam weighed approximately 3.7 kips. Figure 36 shows collected deflection data at Locs. 3 and 10. For tests that had loads applied a midspan of both spans, data was recorded as spreaders were sequentially placed onto the grillage. Measured deflections exactly matched elastic analysis results. Figure 37 illustrates collected strain data. Corresponding stresses are comparable to calculated stresses in Table 19.

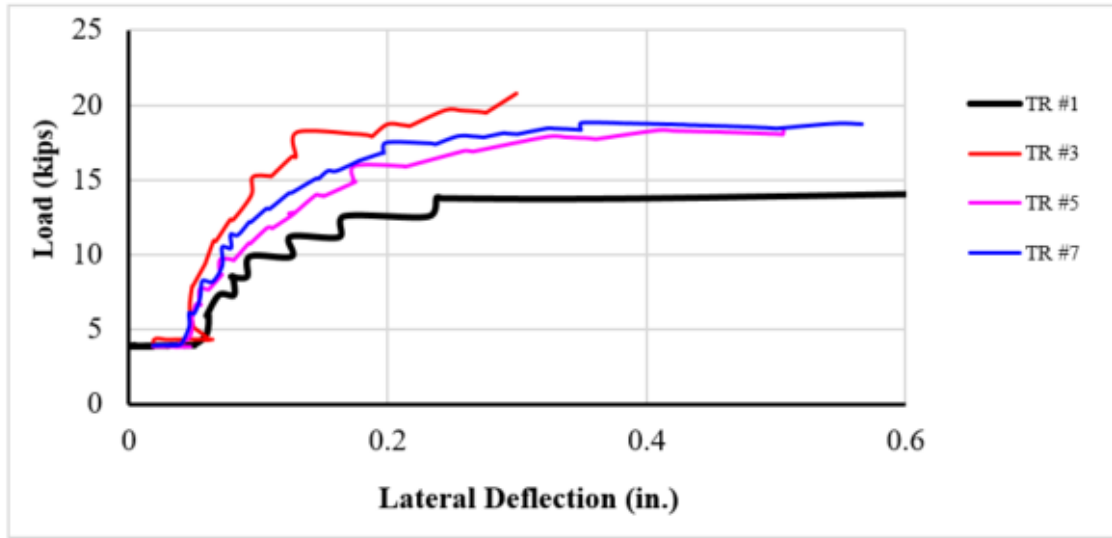
Figure 39. Load-lateral deflection plots, Test Runs #1, 3, 5, and 7

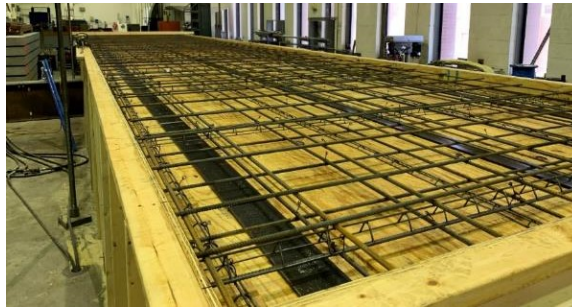
Figure 101. Deck reinforcement

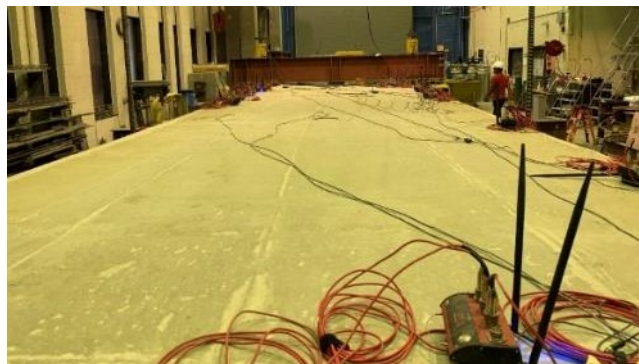
Figure 132. Test Run #45 Failure 3 setup (load at Loc. 10)

This test run was conducted by applying a vertical load at Loc. 10. Figure 132 shows load location and a plan view of the test is illustrated in Figure 133. The load-vertical deflection and load-lateral deflection plots are shown at Locs. 3 and 10 in Figure 134 and Figure 135, respectively. Figure 136 to Figure 139 illustrate the load-stress plots at Loc. 10, including the total stress and stress components at various gauge locations such as TN, TS, BN, and BS. Similar plots are provided in Figure 140 to Figure 143 for Loc. 7 and in Figure 144 to Figure 147 for Loc. 6. The total stress at each location is nearly the same as the primary bending stress, indicating that the weak-axis bending and warping torsion stresses are negligible. Load-stress plots at other representative locations are presented in Appendix V. Strain diagrams at Locs. 10 and 7 subject to various loads are provided in Figure 148 and Figure 149, respectively.

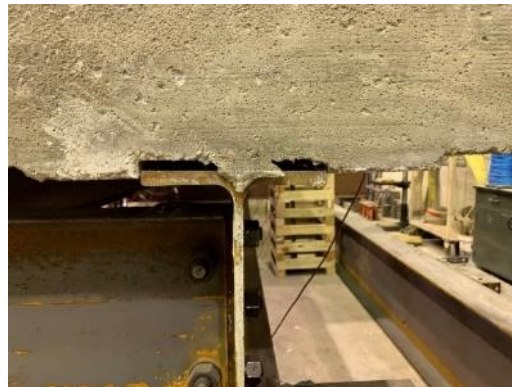
Figure 154. Relative slip at end support

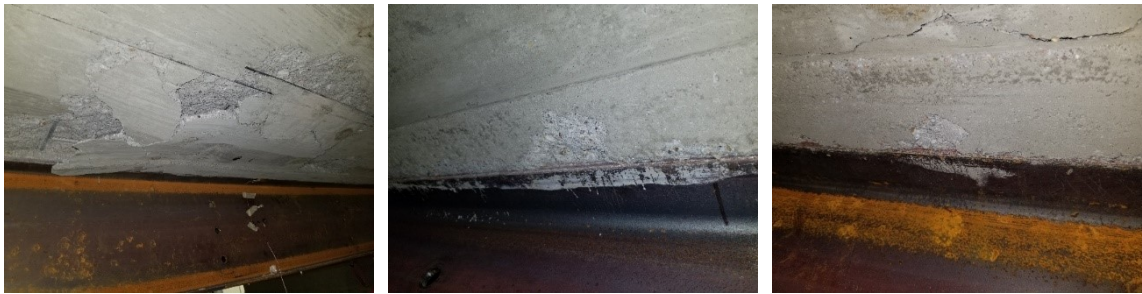
Figure 167. Deck soffit at various locations after testing

(a) Interior stringer near Loc. 3 (b) Exterior stringers near Locs. 13 & 17 (c) Interior stringer near Loc. 10
