# Historic Bridge Management Plan for the Perkins Road Overpass

Recall Number: 610023

Structure Number: U1730258910961

August 2016

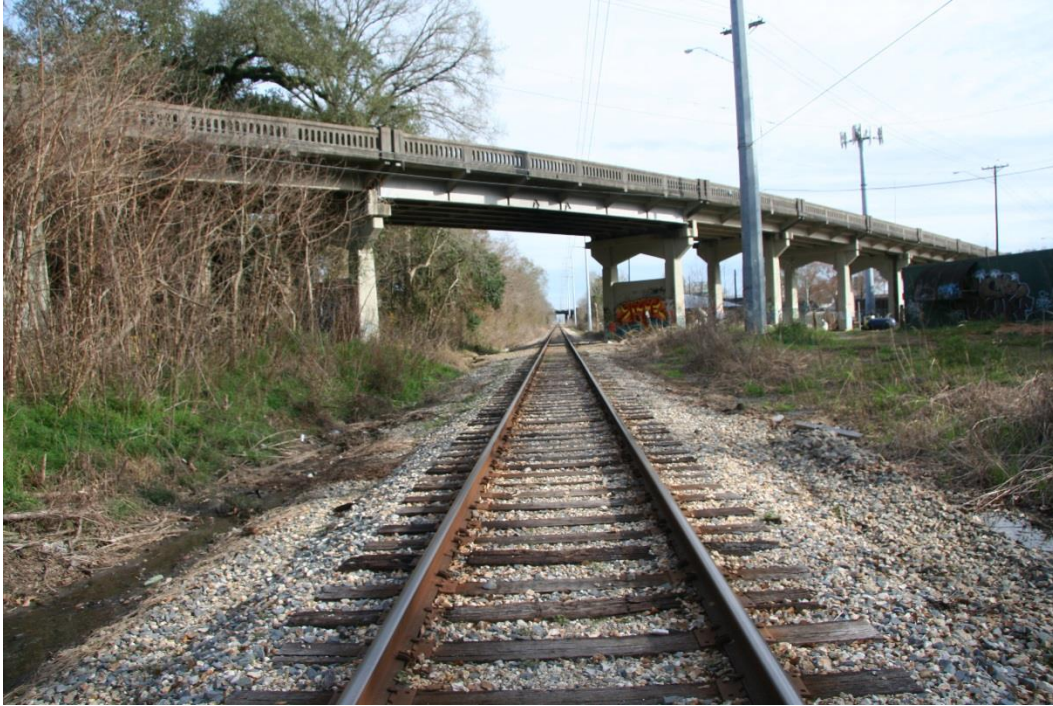
*Character-defining Feature Photo 1: Design and construction of a railroad grade-separation overpass. The steel I-beam span, which crosses the railroad, and adjacent concrete deck girder spans comprise the superstructure.*

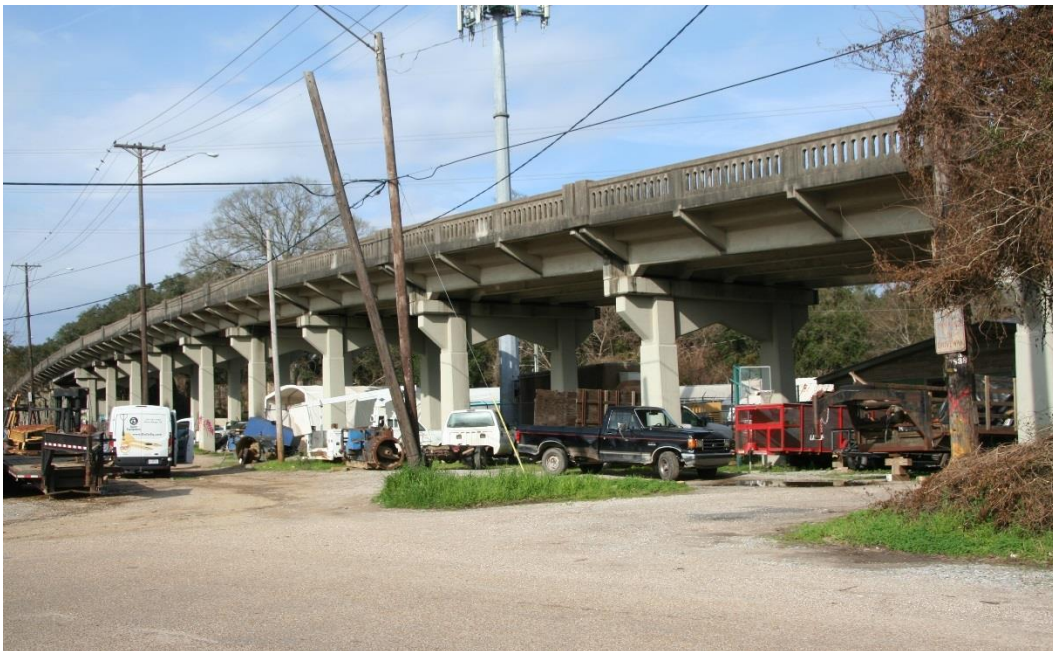
*Character-defining Feature Photo 2: Design and construction of a railroad grade-separation overpass. The steel I-beam span, which crosses the railroad, and adjacent concrete deck girder spans comprise the superstructure.*

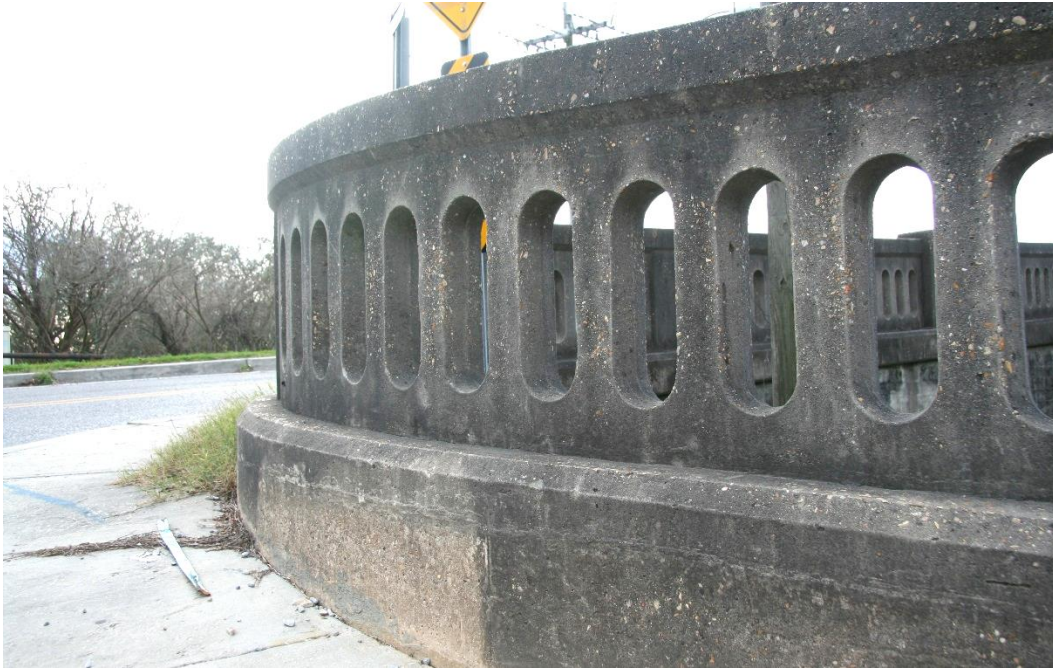
*Character-defining Feature Photo 3: Aesthetic treatment of decorative open balustrade railings conveys the bridge's architectural significance.*

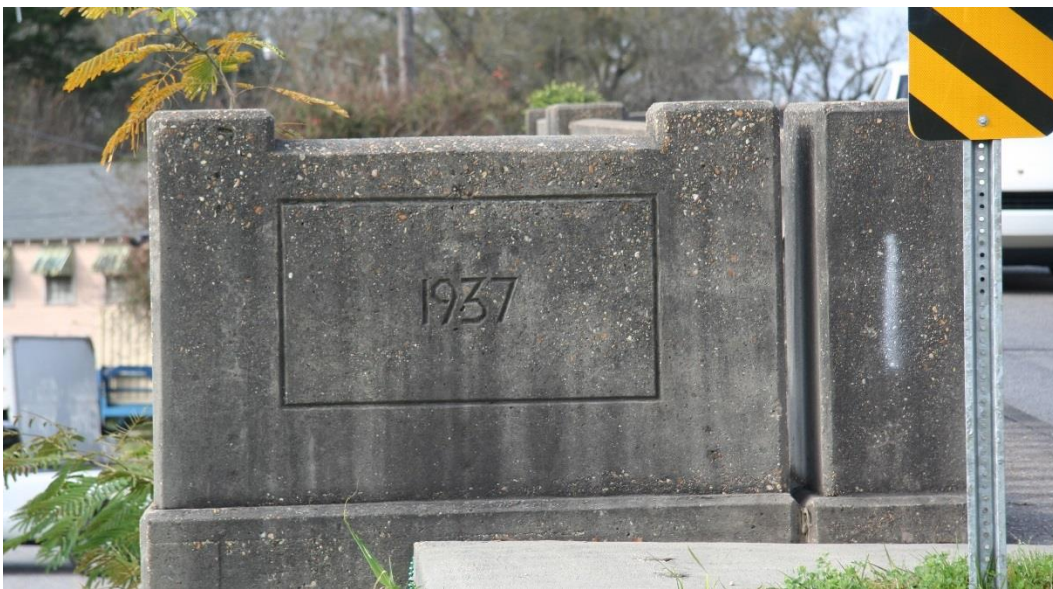
*Character-defining Feature Photo 4: Aesthetic treatment of geometric endposts contributes to the overall design treatment of the overpass.*

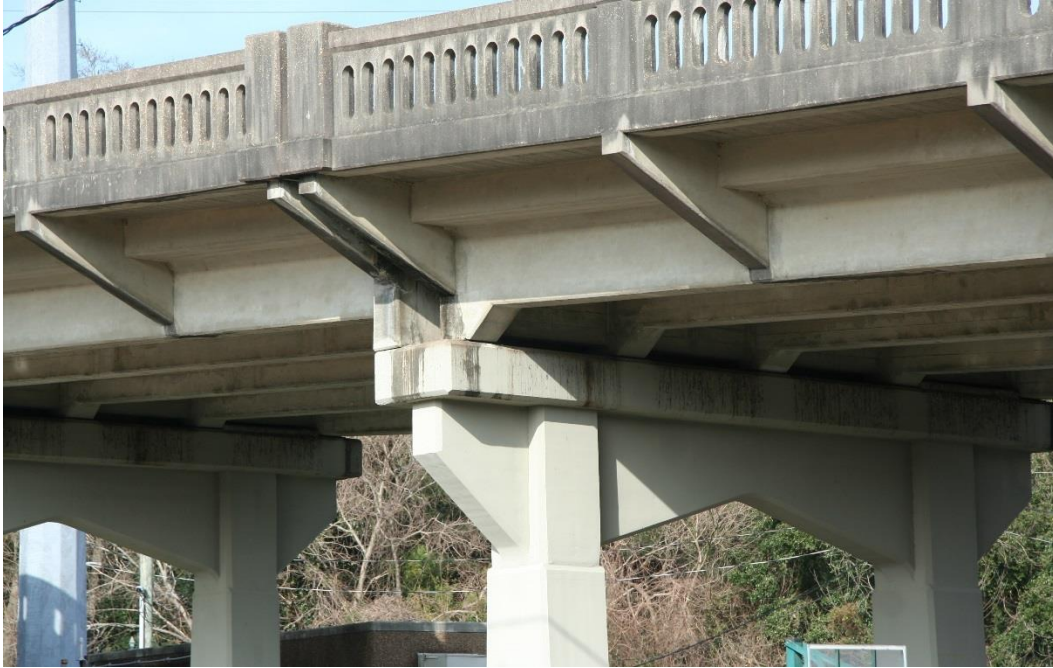
*Character-defining Feature Photo 5: Aesthetic treatment of brackets supporting the cantilevered sidewalk and angular pier caps demonstrates the architectural features of this bridge.*

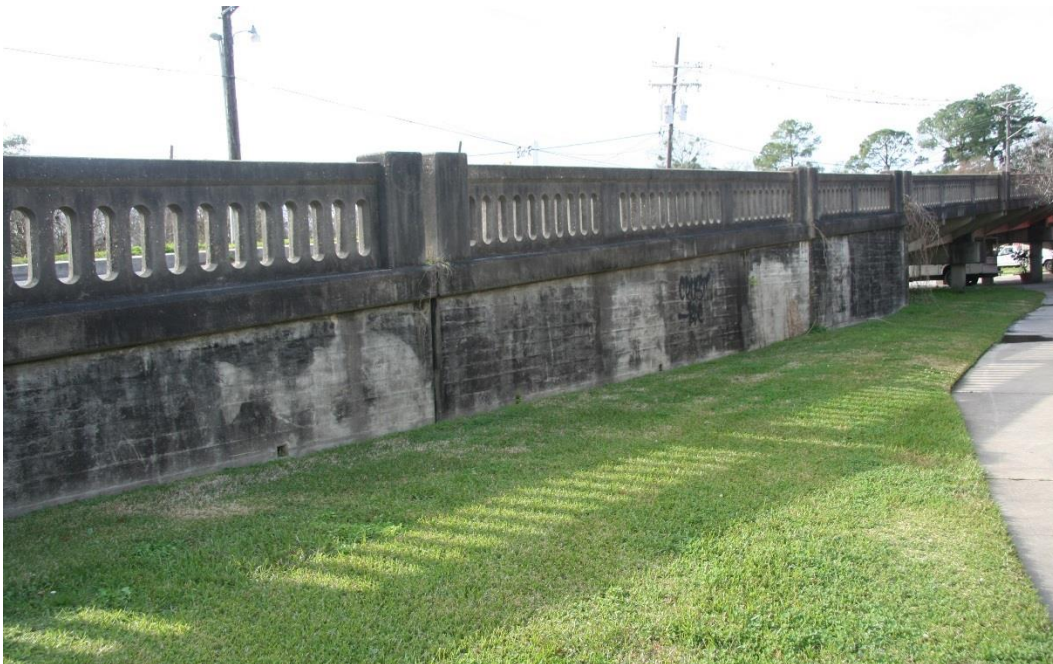
*Historic Fabric Photo 1: Concrete retaining wall at the southeast corner of the bridge.*

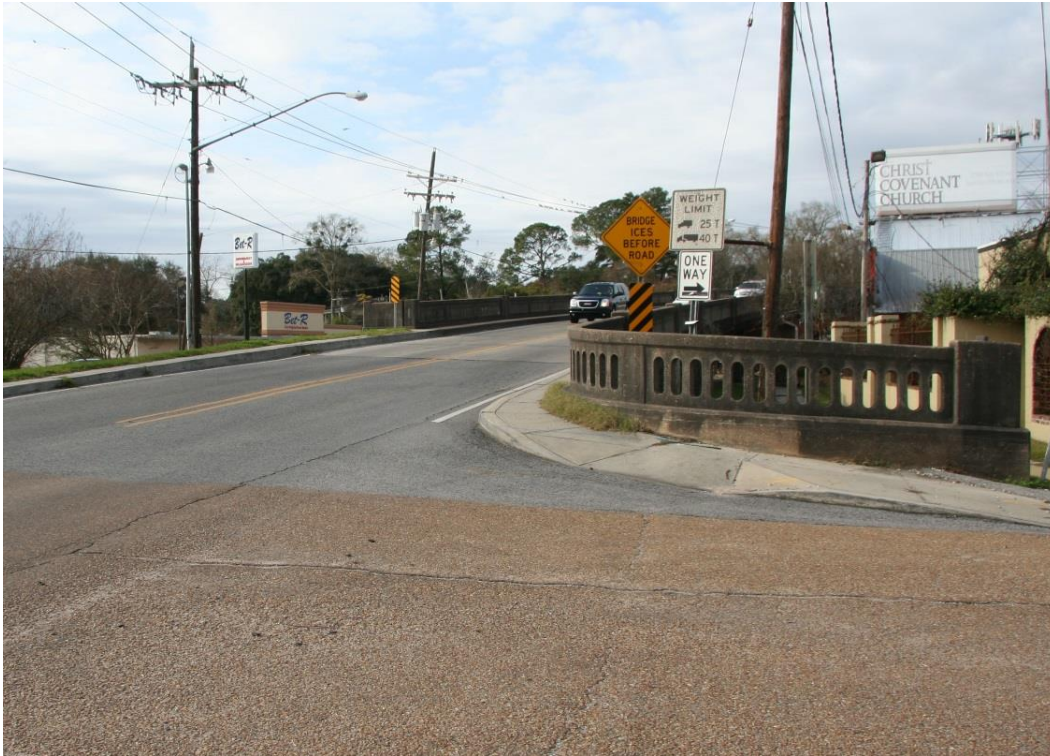
*Condition Photo 1: South end of bridge approach roadway and bridge railing.*

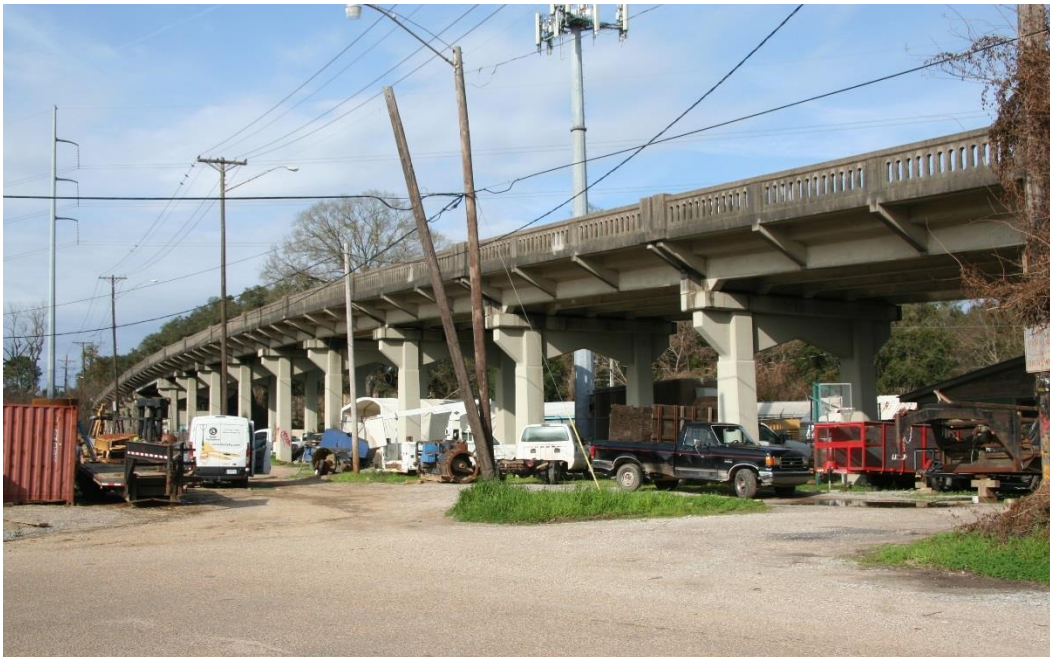
The substructure units are in fair condition, with only minor deficiencies. All piers were given a cementitious coating as part of the 2009 rehabilitation. At pier 2 the condition is fair because there are areas of delamination of the coating along the ground line from fires under the bridge. There is extensive graffiti on the piers located on each side of the railroad, and on other piers randomly along the length of the bridge. Vegetation is growing on pier 16 and reaching up to the parapet of the superstructure.

*Condition Photo 2: View of west elevation of bridge. Note coating of piers from 2009 rehab.*

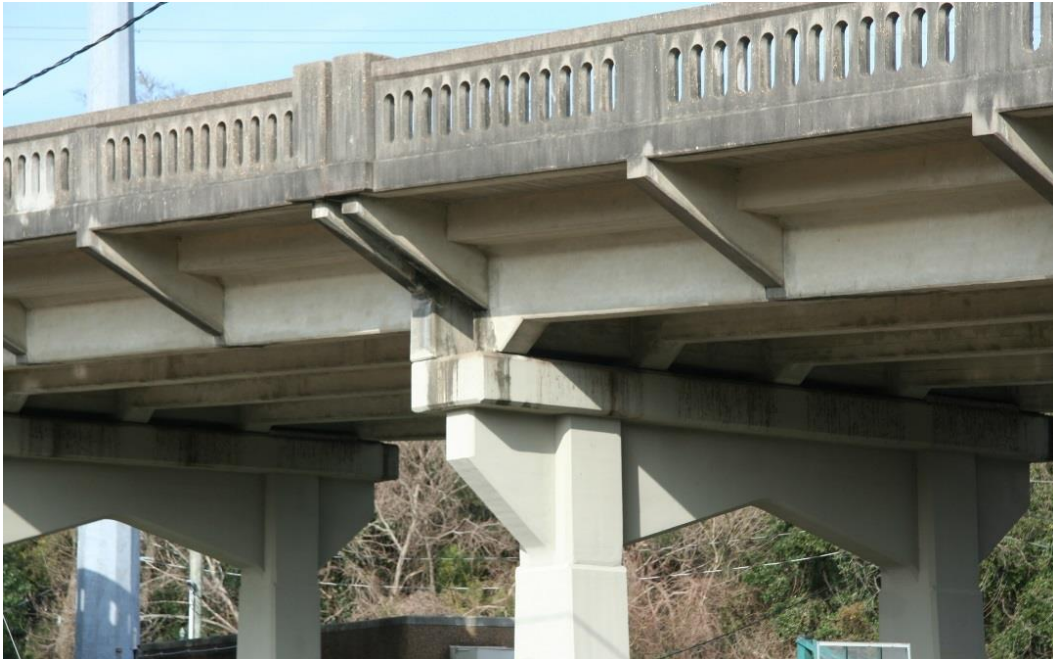
*Condition Photo 3: Typical superstructure and pier.*

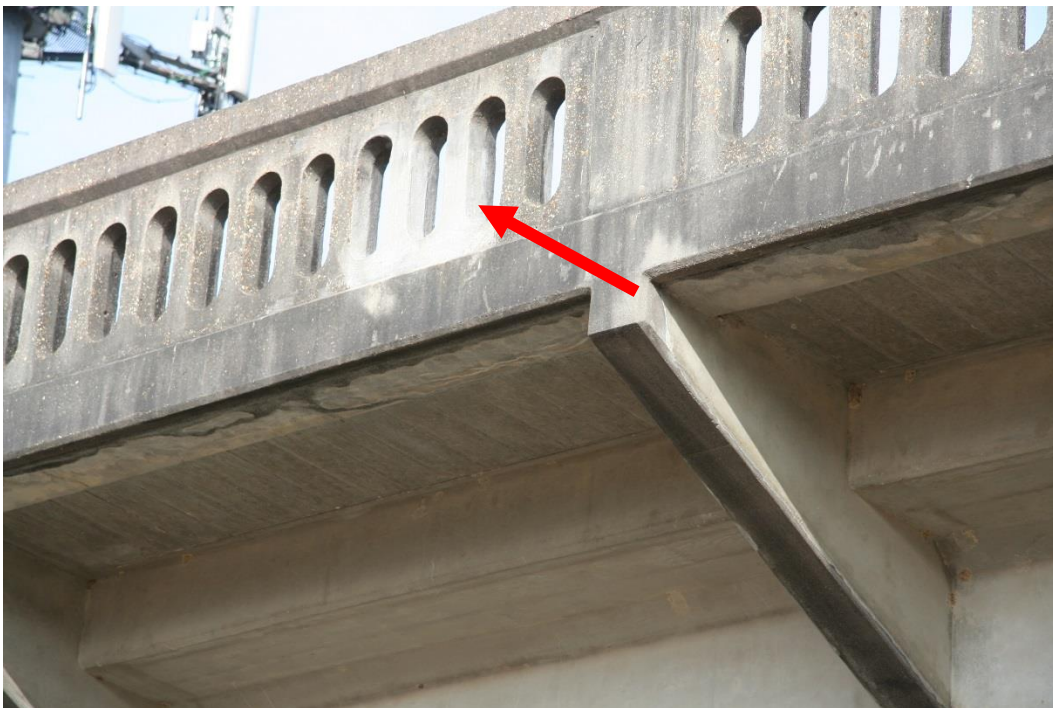
*Condition Photo 4: Repair of section of bridge parapet. Note variation of concrete color and texture.*

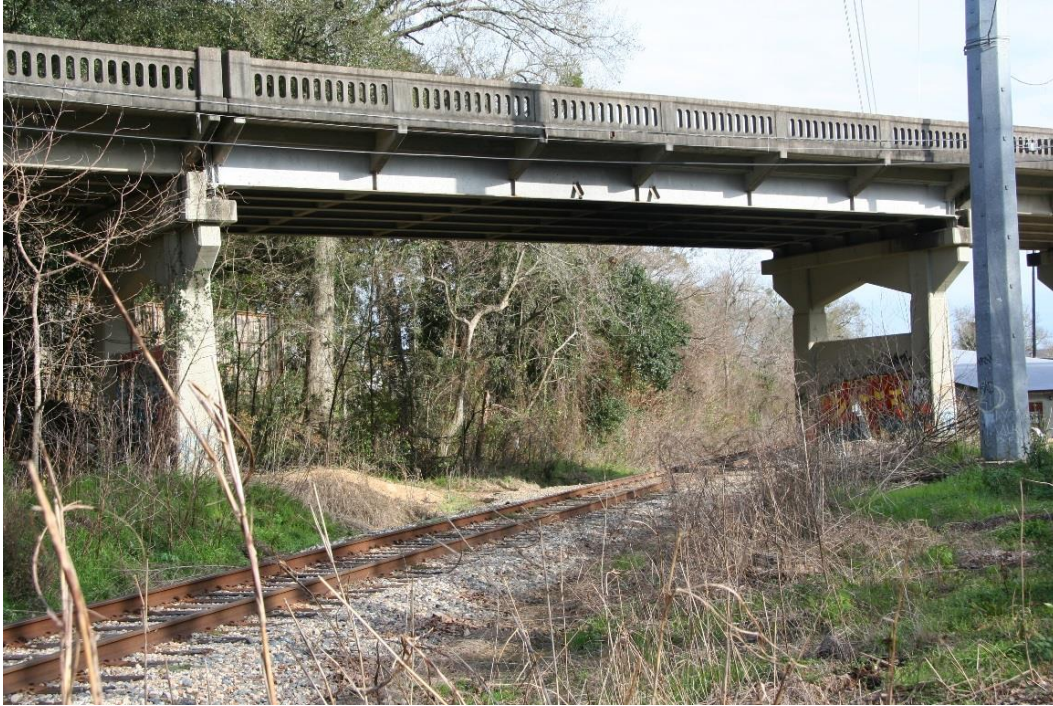
*Condition Photo 5: Steel I-Beam span over railroad.*

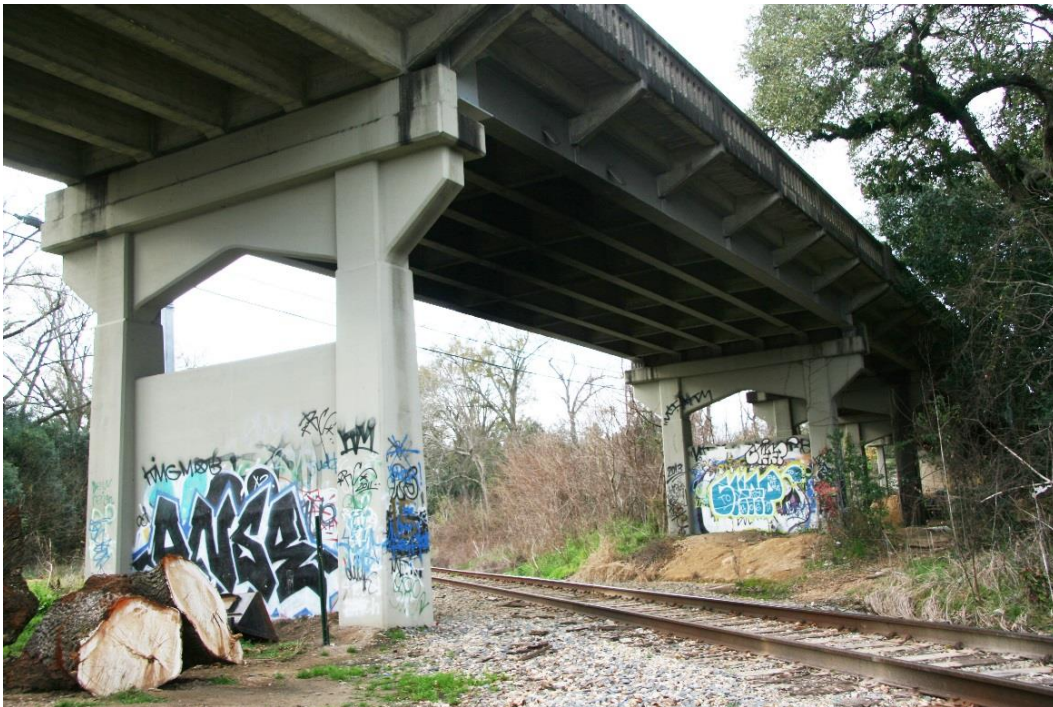
*Condition Photo 6: Piers at railroad with graffiti.*

1. Clean dirt and debris from the bridge deck, including expansion joints, and sidewalks regularly to maintain good condition.
2. Recoat or paint over graffiti on the bridge piers and other units with a coating of paint that matches the color, consistency, and texture of the existing coating. The recoating or painting

should be limited to the area of graffiti only and this practice to cover graffiti should not be done elsewhere on the bridge.

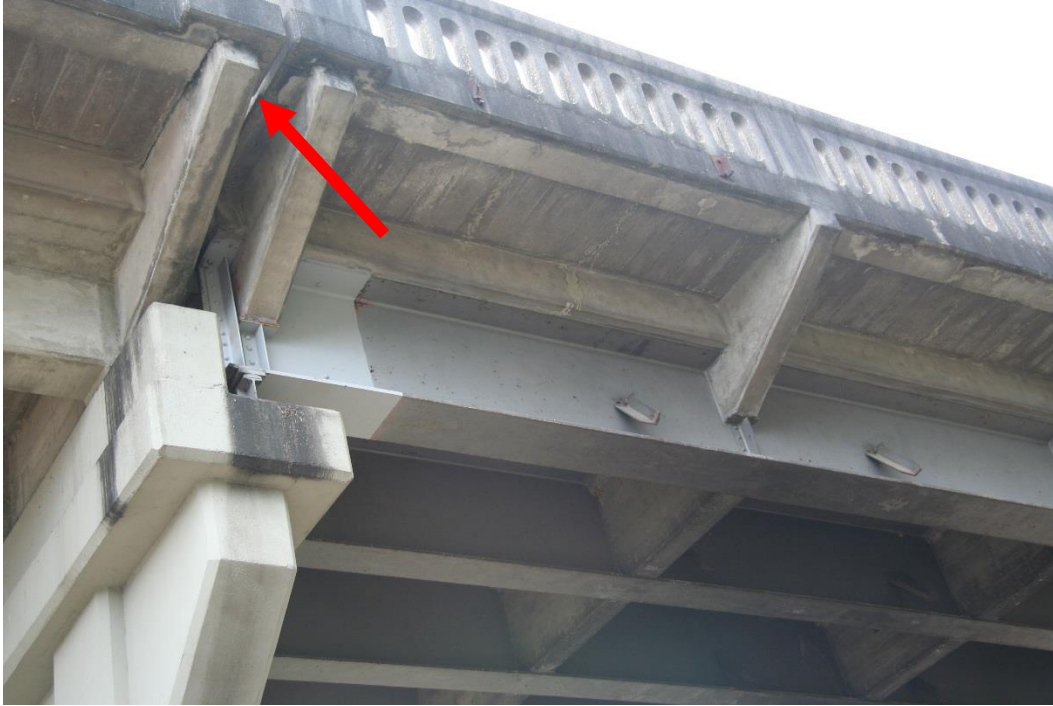
Steel blast plates were provided in the original construction on the underside of the steel beams to protect the steel beam span from smoke from steam locomotives. These blast plate elements have been removed, but small portions of the steel support brackets remain on the exterior faces of the exterior beams. These brackets do not affect the vertical clearance over the railroad, nor do they pose any structural concern for the strength of the steel beams.

*Condition Photo 7: End of steel beam span at pier. Note additional painting of ends of steel beams, expansion joint in deck above, and two remaining steel angle members attached to the beam from the removed metal blast plates and their supports.*

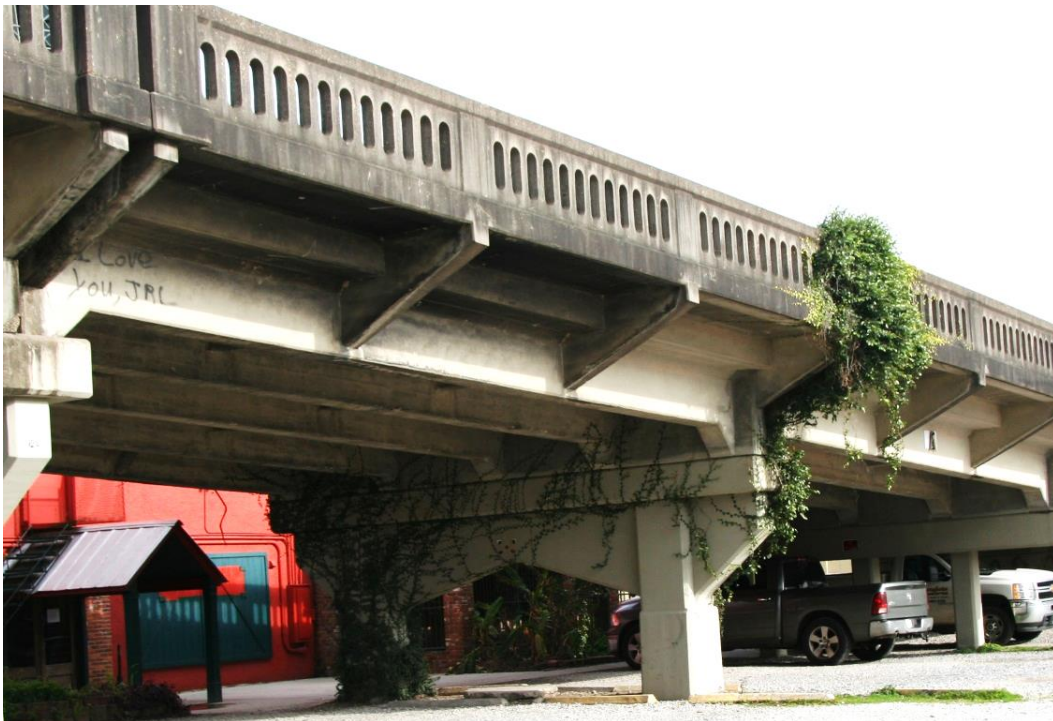
*Condition Photo 8: Vegetation growing on pier and superstructure.*

3. Remove all vegetation from the bridge including the vines growing at Pier 16.

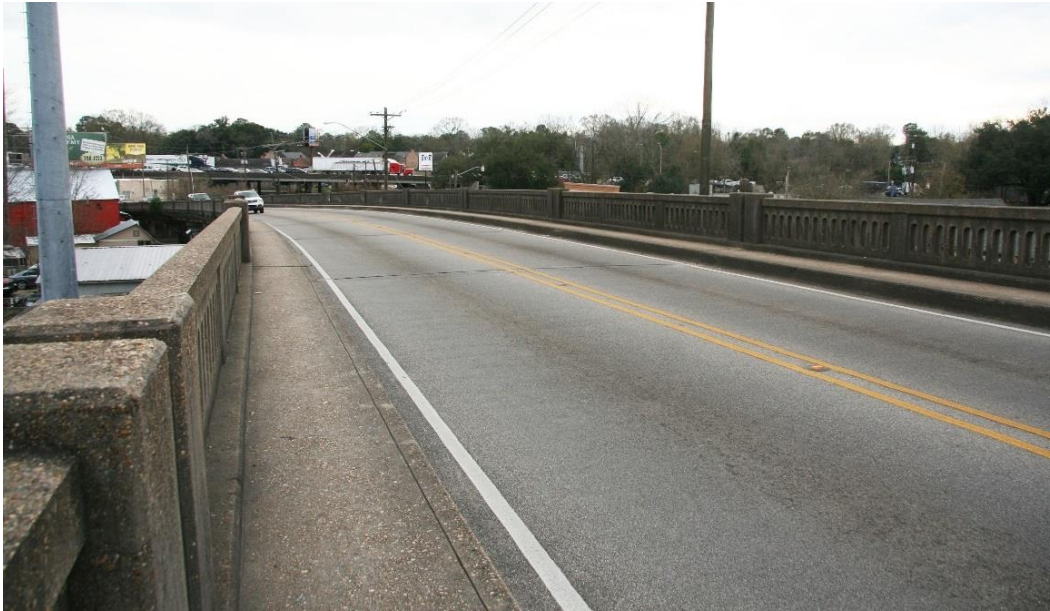
The superstructure is in good condition, with only minor deficiencies. The concrete sidewalk surfaces are in fair condition having minor scaling with exposed aggregate throughout. The concrete railings are in fair condition having minor scaling with exposed aggregate throughout. The expansion joint “gland” in the deck joint at pier 7 has failed because it is torn with debris buildup. Other expansion joints in the bridge deck have some minor debris buildup but are in satisfactory condition.

*Condition Photo 9: General condition of bridge deck, sidewalks, and railings.*

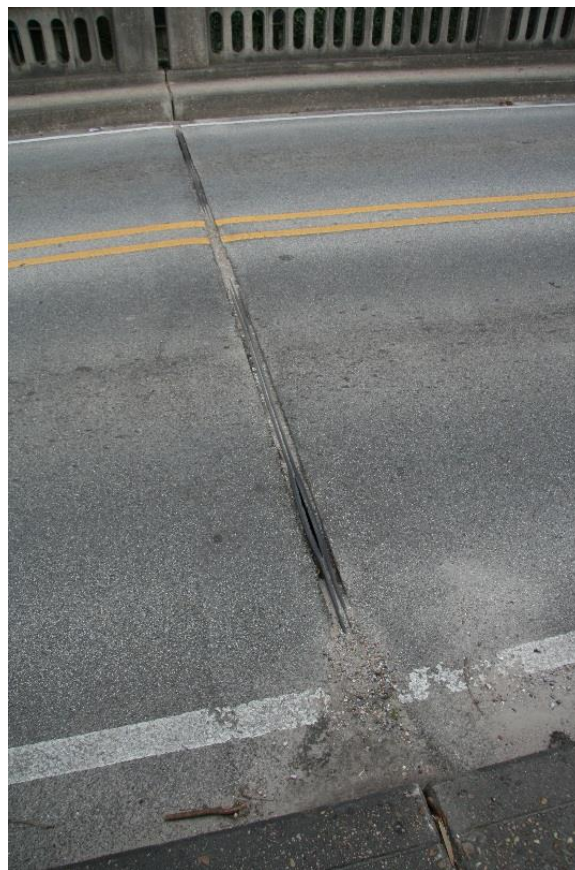
*Condition Photo 10: Typical roadway expansion joint in approach spans.*

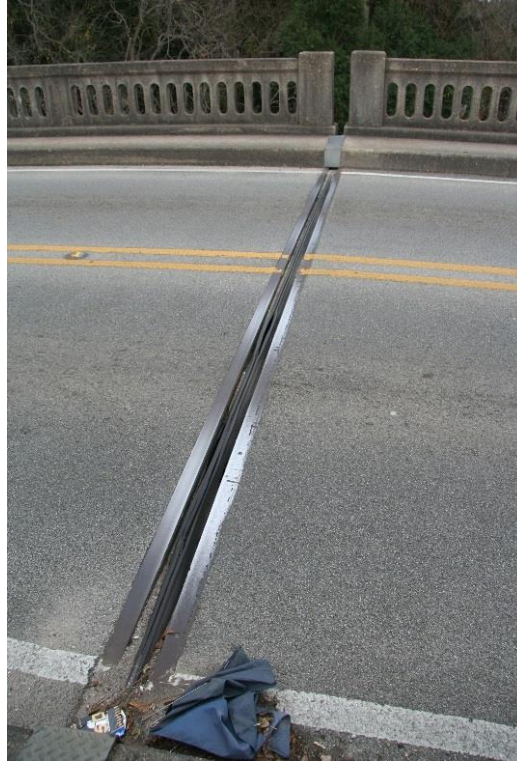
*Condition Photo 11: Roadway expansion joint near Pier 7 at steel beam span over railroad.*

1. Replace the neoprene/rubber “gland” in the expansion joint in the bridge deck at Pier 7.
2. Repair the coating and delamination due to fire damage at Pier 2. Repairs should match the color, texture, and consistency of the existing coating and adjacent concrete.

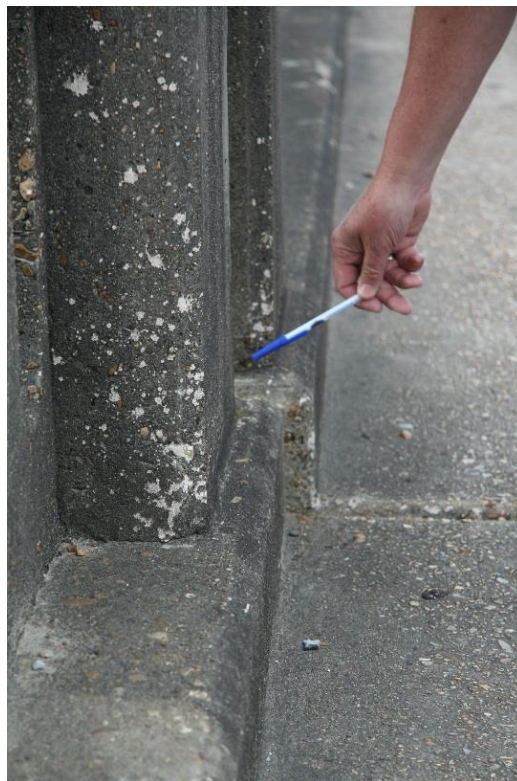
*Condition Photo 12: Approximately 1-inch offset between parapets and deck at pier 8 (spans 7 and 8).*

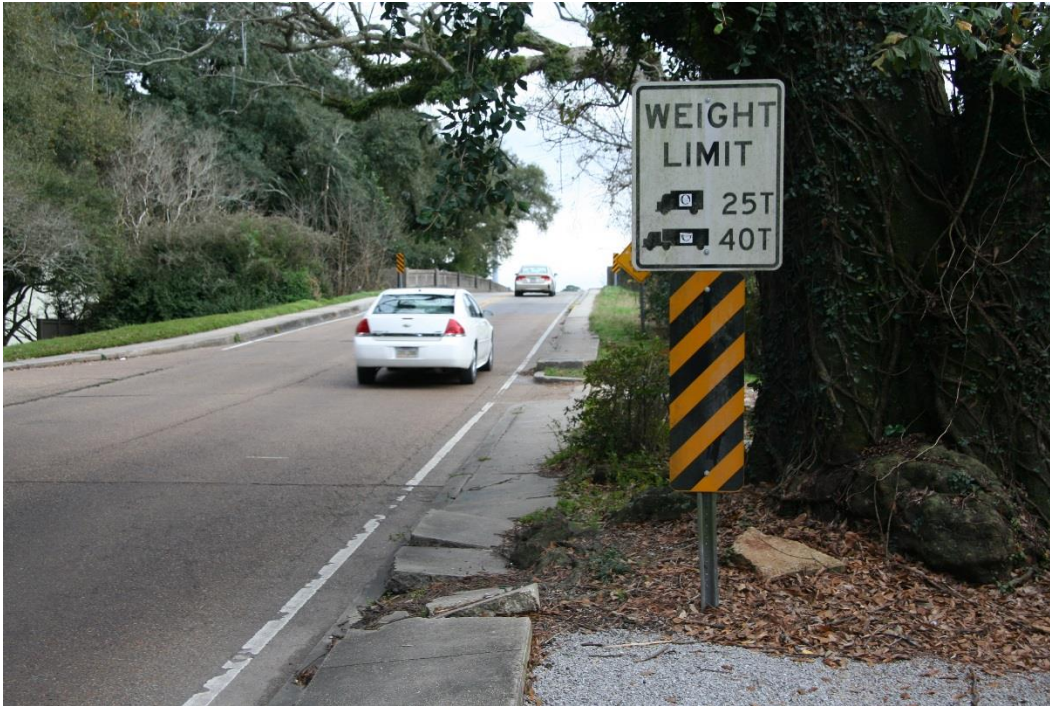
*Condition Photo 13: North end of bridge approach roadway, including sidewalk.*

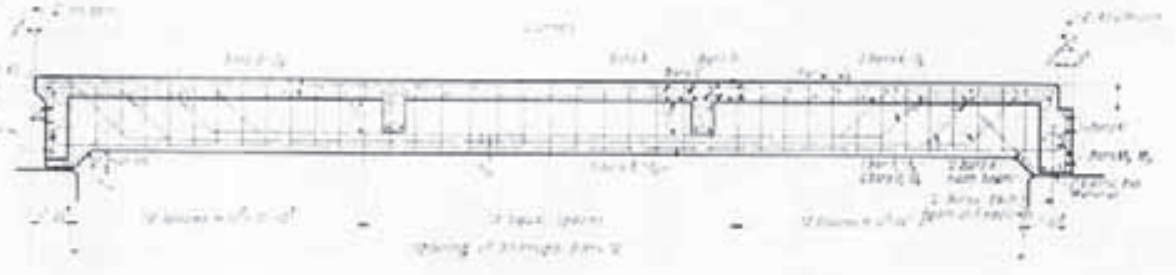
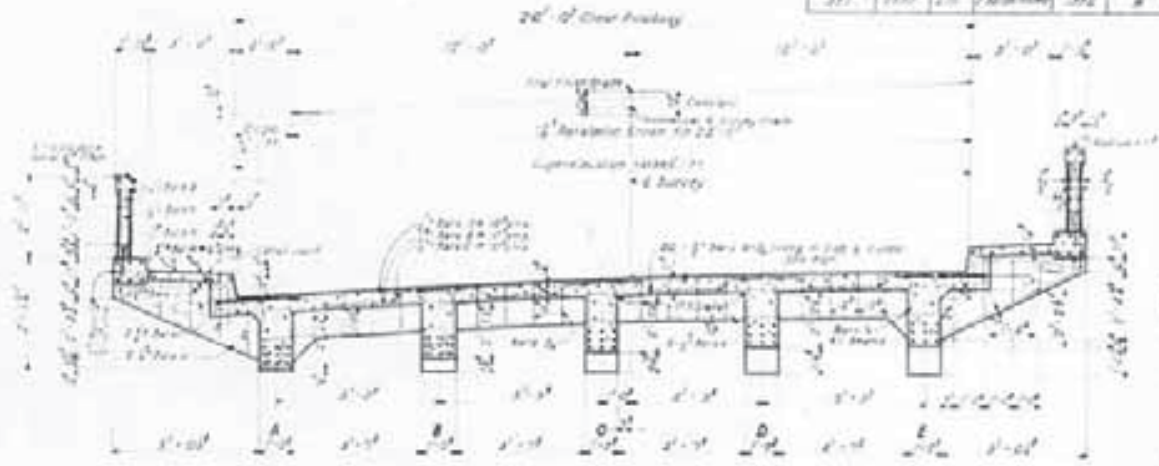
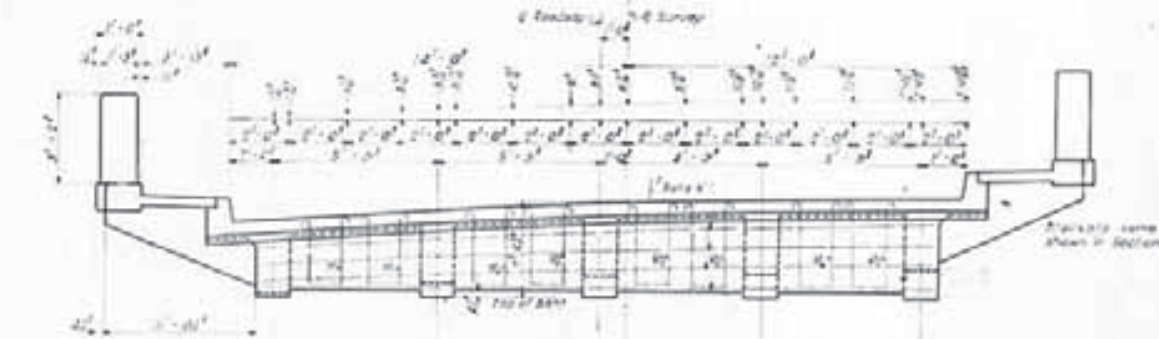
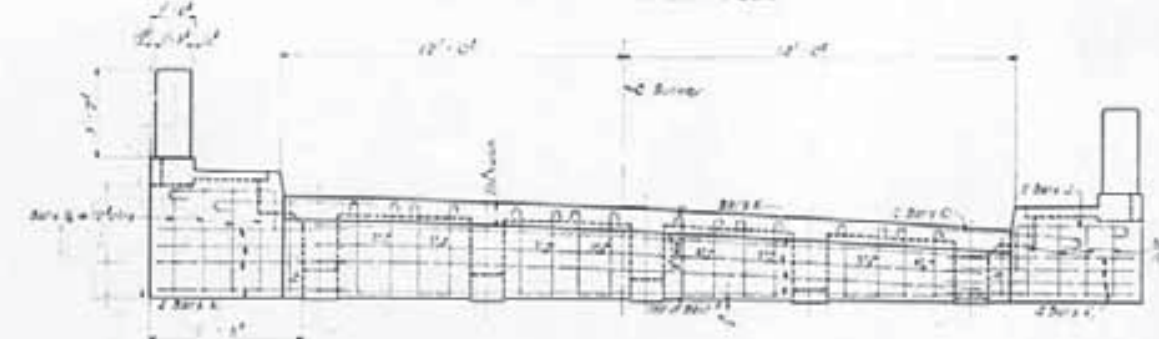
**DETAIL OF R.C. DECK GIRDER FOR  
 SPANS N° 13-20  
 HUNDRED OAKS OVERPASS  
 L & A RAILWAY**

TYPICAL LONGITUDINAL SECTION

PLAN  
Showing Reinforcement

SECTION A-A

END ELEVATION - INTERMEDIATE BENT

END ELEVATION - ABUTMENT
