Historic Bridge Management Plan for the Mississippi River (Sunshine) Bridge

Recall Number: 203760

**Mead
& Hunt**

March 2017

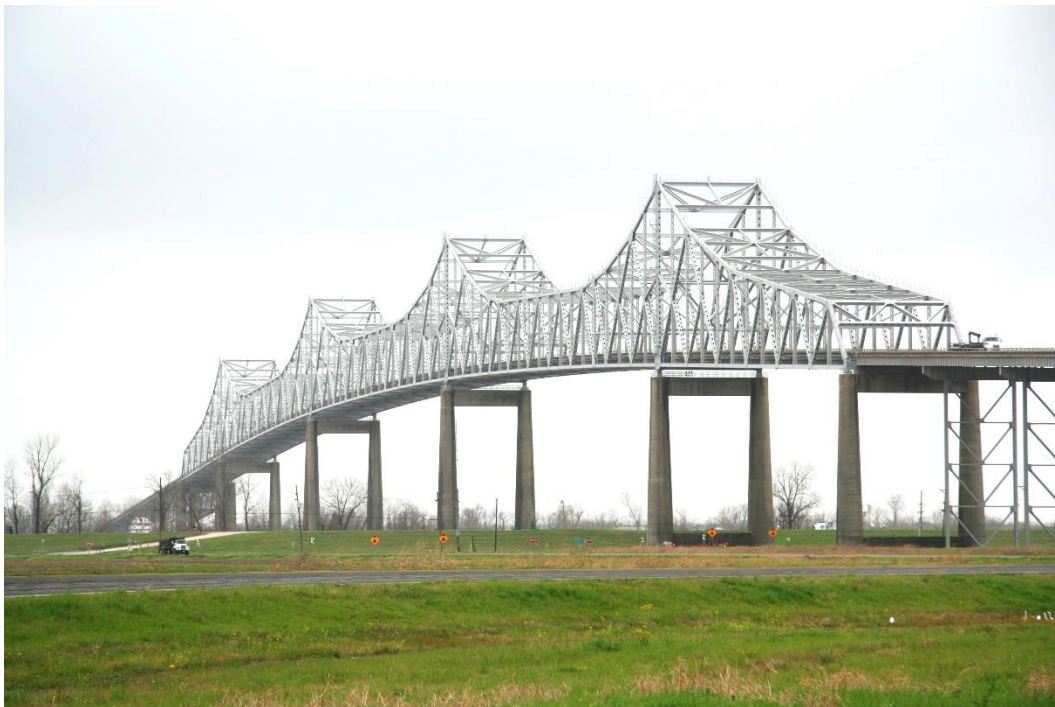
Character-defining feature Photo 1: Design and construction of a continuous Warren through truss. The Warren truss features diagonal members to withstand both tensile and compressive forces, and added verticals for bracing.

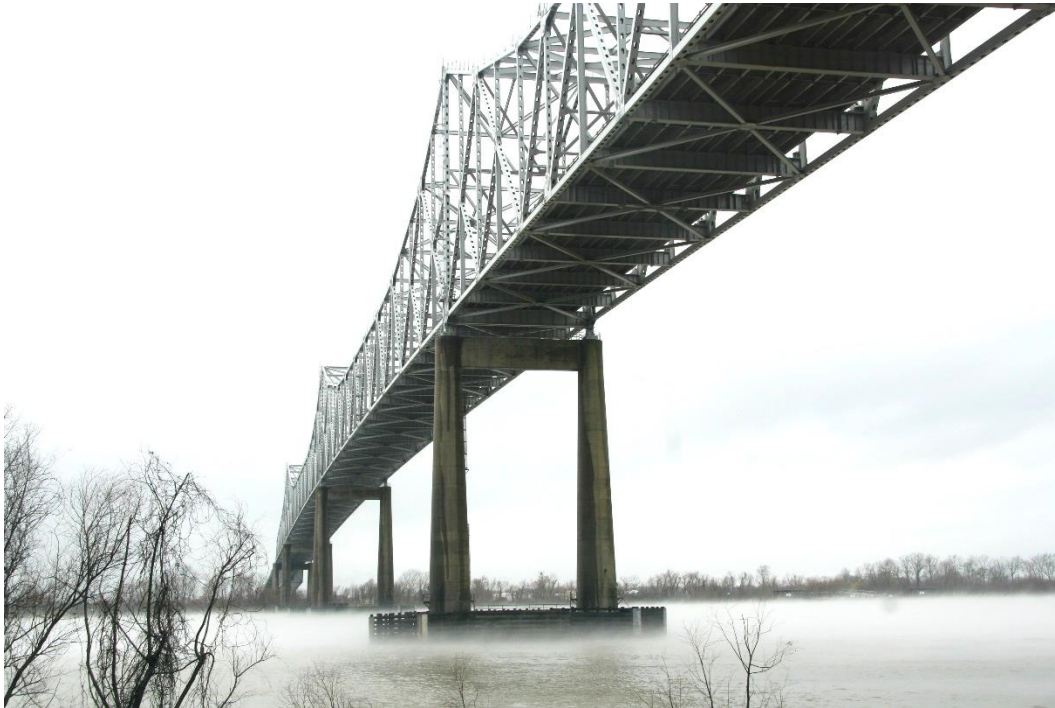
Character-defining Feature Photo 2: Caisson-constructed piers.

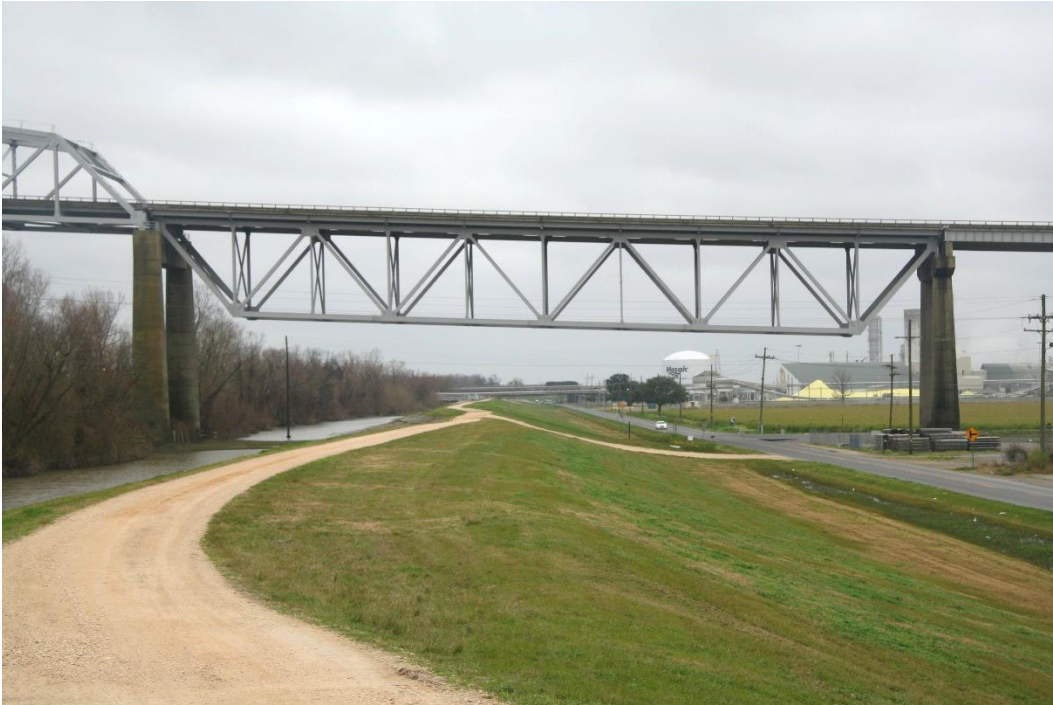
Historic Fabric Photo 1: Deck truss approach span to the west of the main Warren through truss spans, spanning LA 18 and the westerly levee of the Mississippi River, and approach piers.

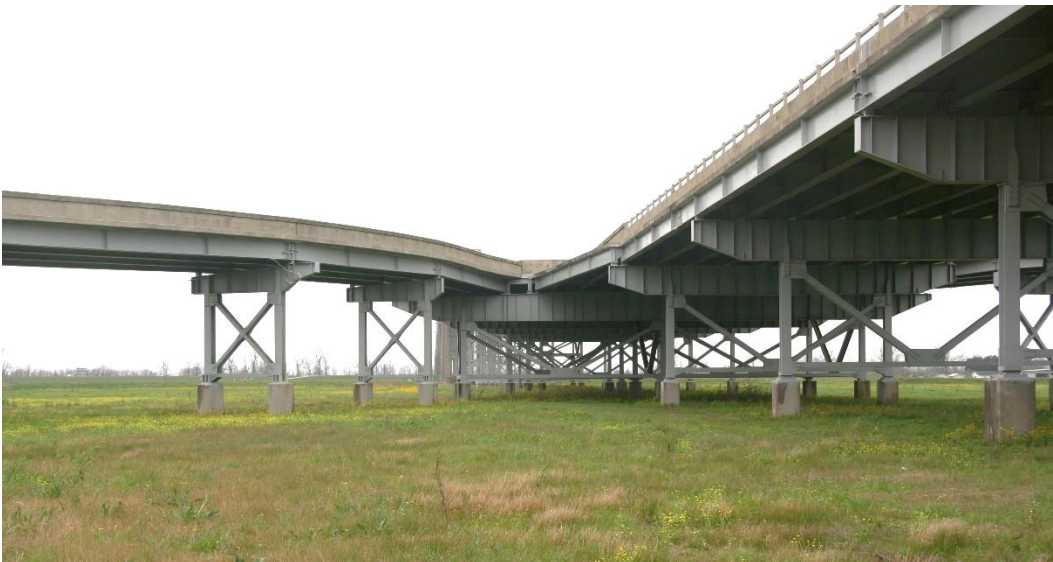
Historic Fabric Photo 2: Y-shaped approach ramp spans at the easterly end of the bridge, including floor system and braced steel column towers.

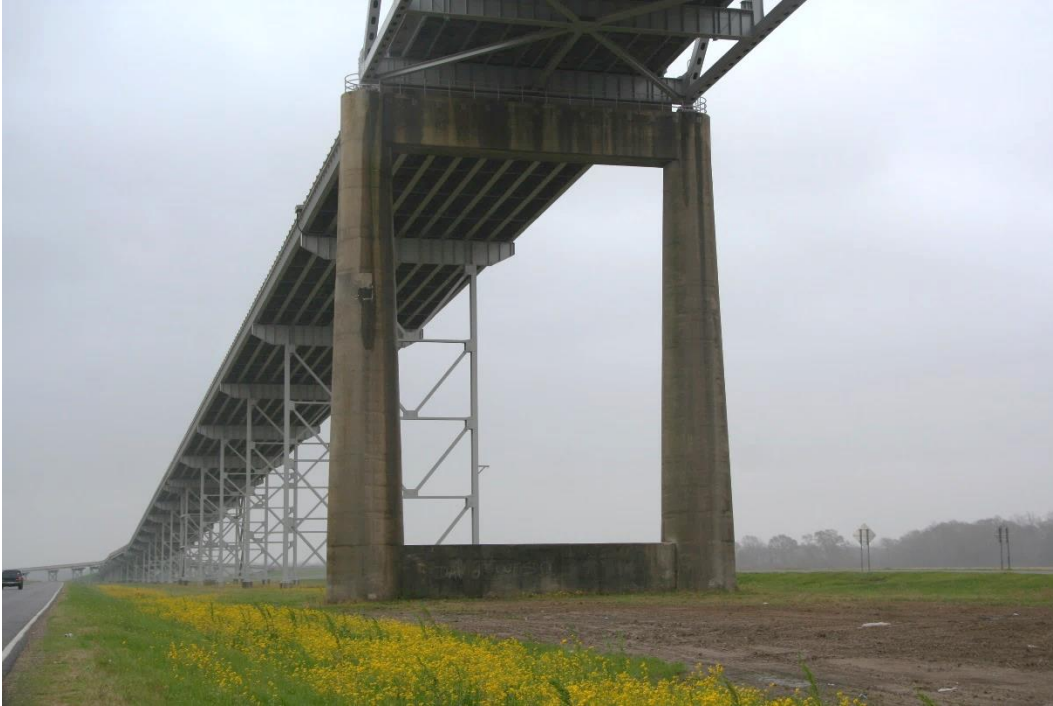
Historic Fabric Photo 3: Approach spans to the east of the main Warren through truss spans including floor system, braced steel column towers, and approach piers.

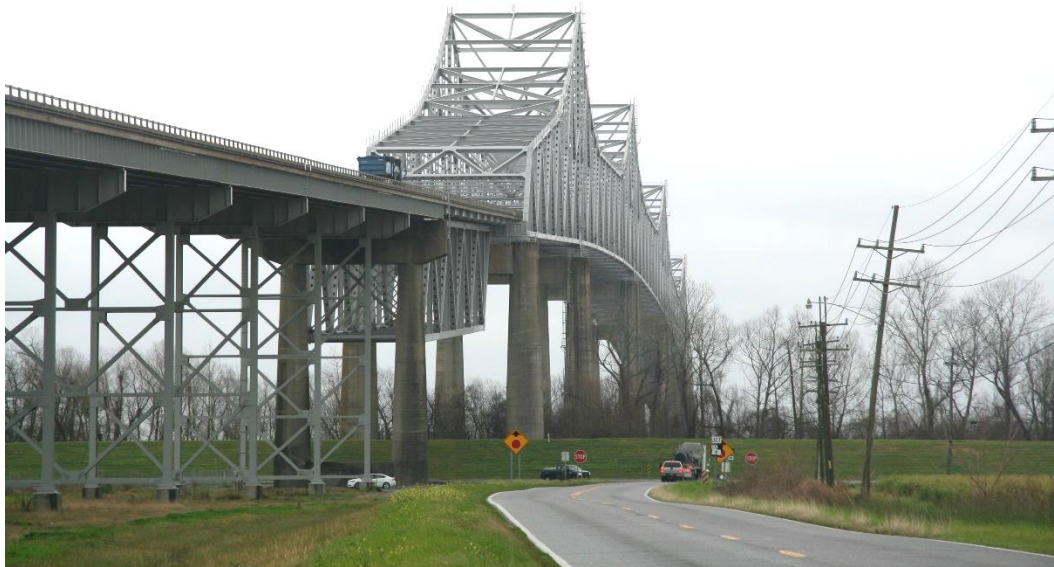
Condition Photo 5: Westerly approach spans and truss span over LA 18.

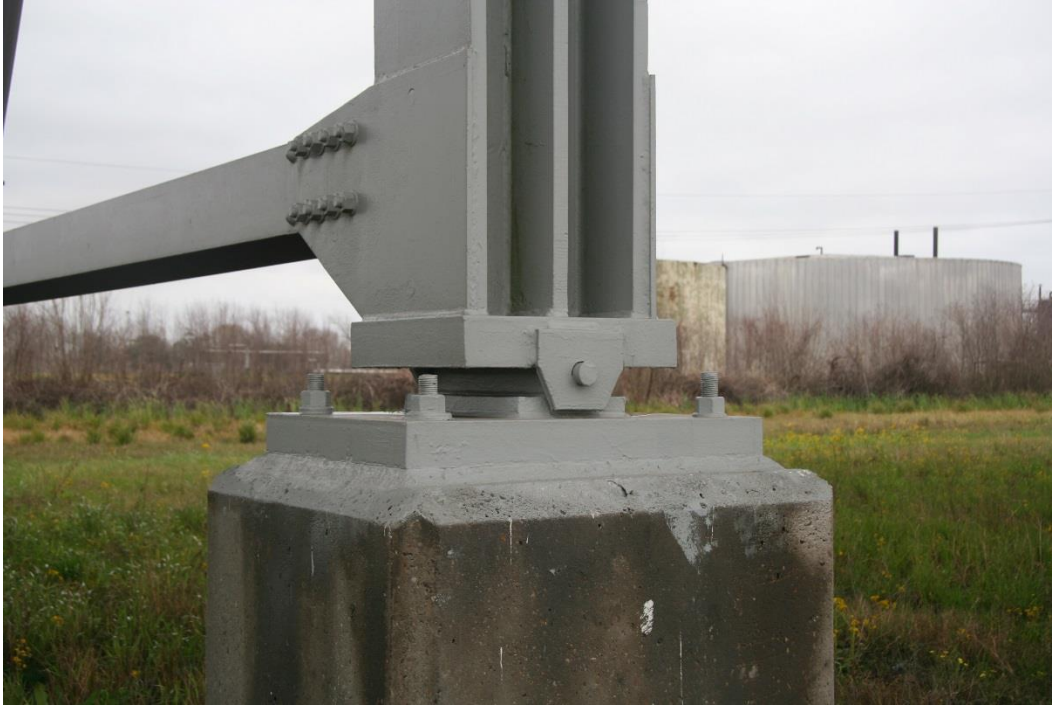
Condition Photo 7: Column base detail for westerly approach spans.

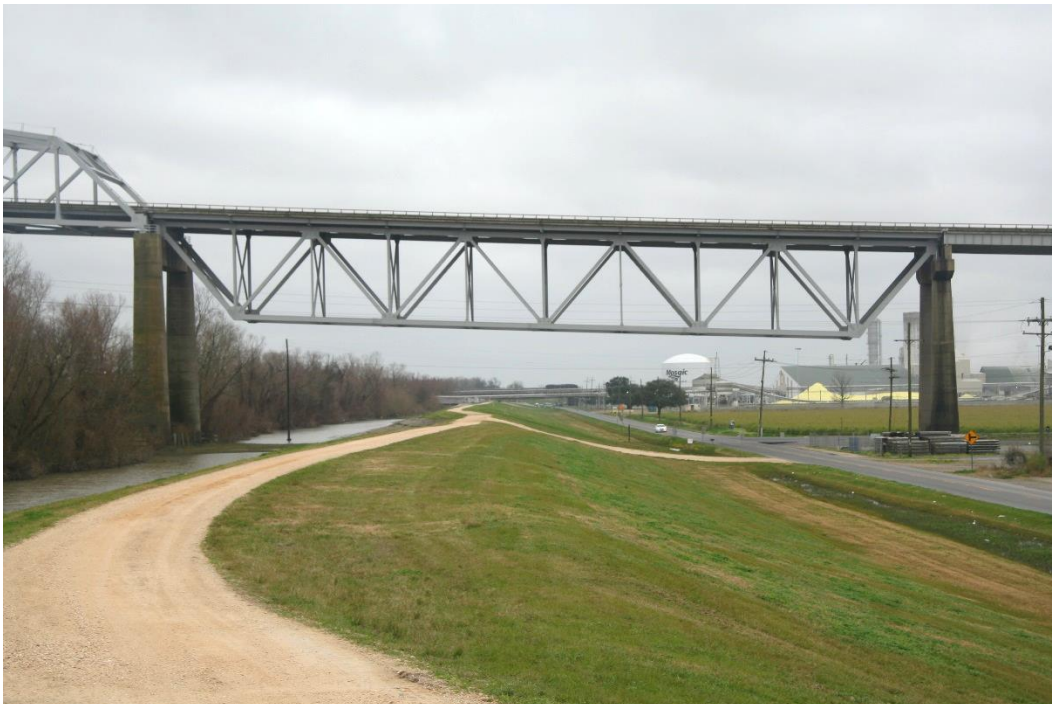
Condition Photo 8: Deck truss span 18 over LA 18 and west levee.

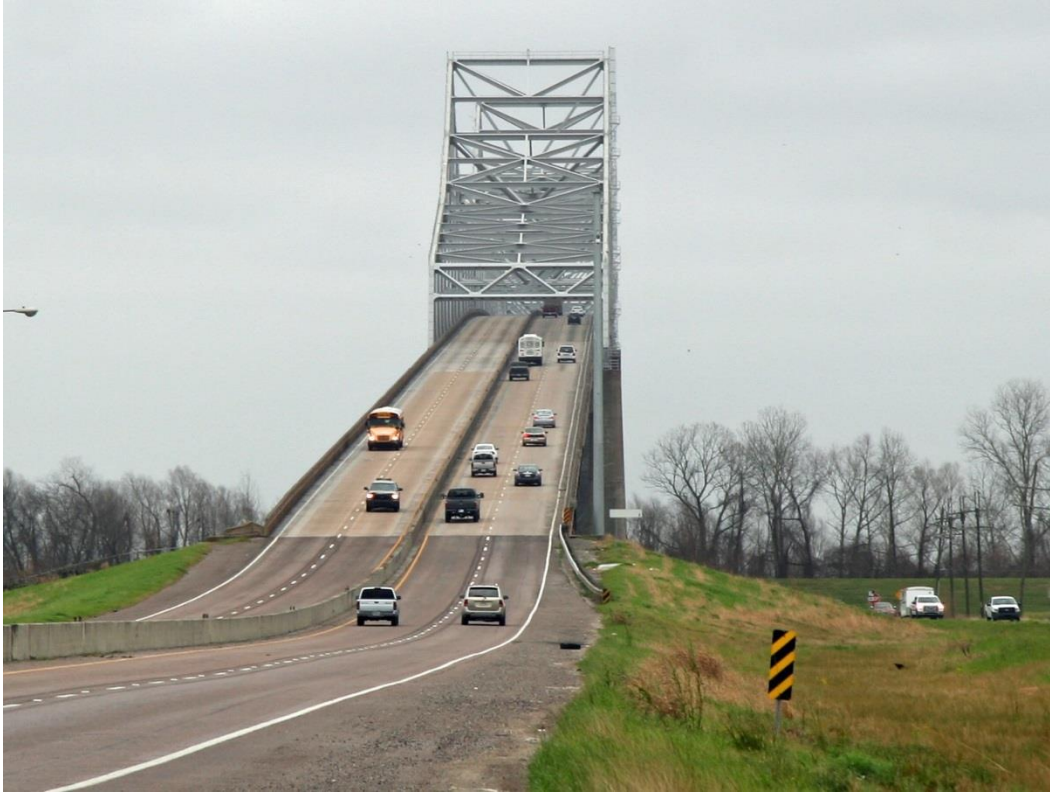
Condition Photo 9: View from west end of bridge looking east toward the bridge.

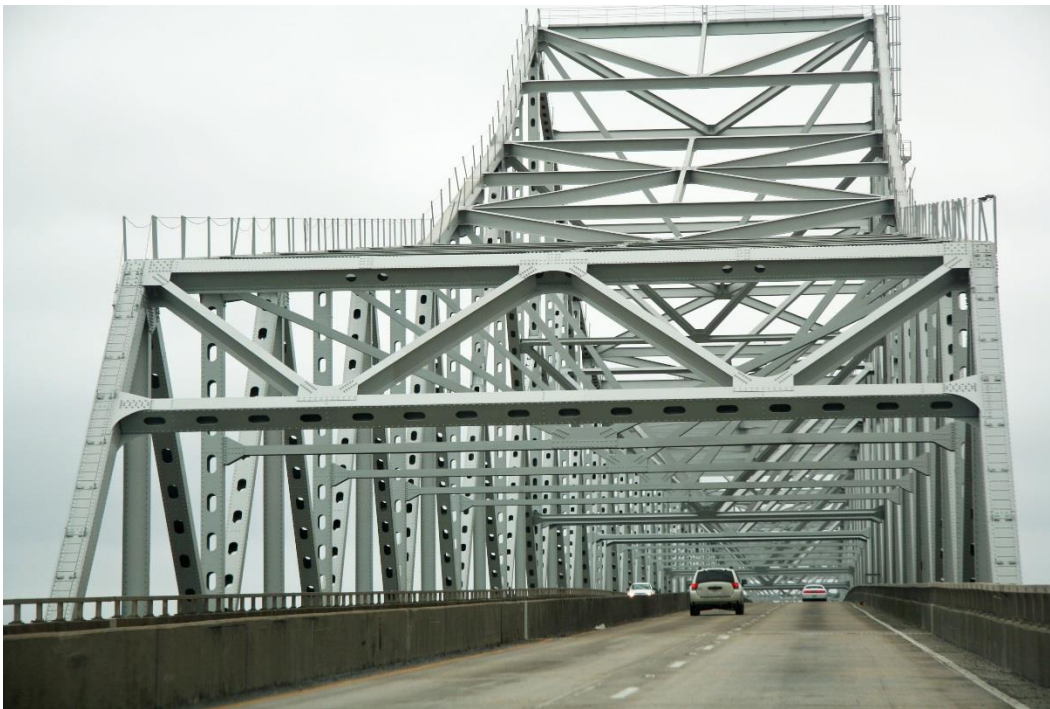
Condition Photo 10: Eastbound roadway through truss spans.

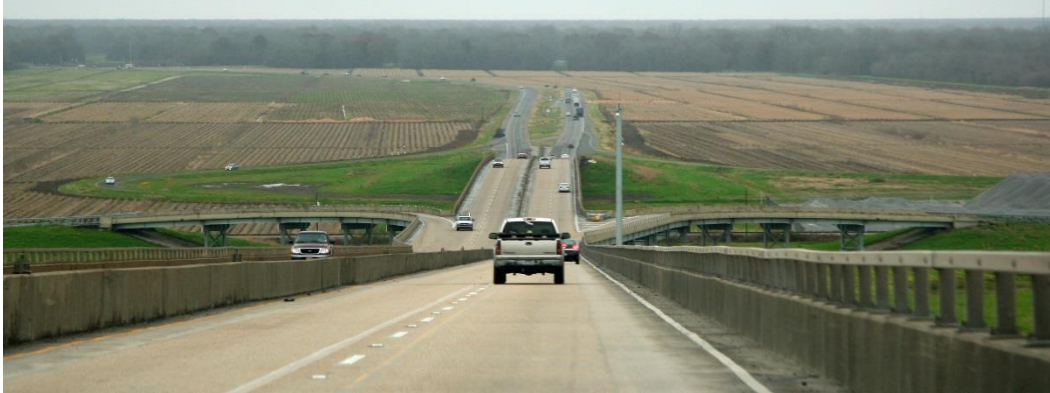
Condition Photo 11: Eastbound roadway looking east at easterly Y-split in ramps at end of bridge.

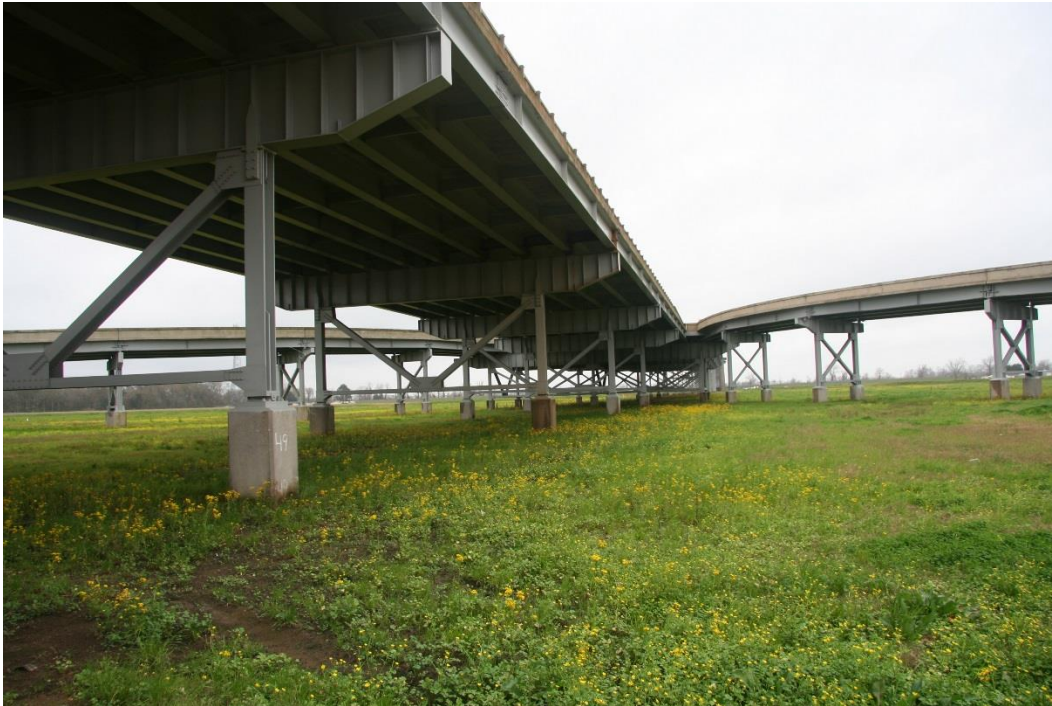
Condition Photo 15: Y-shaped split of ramps at east end of bridge.

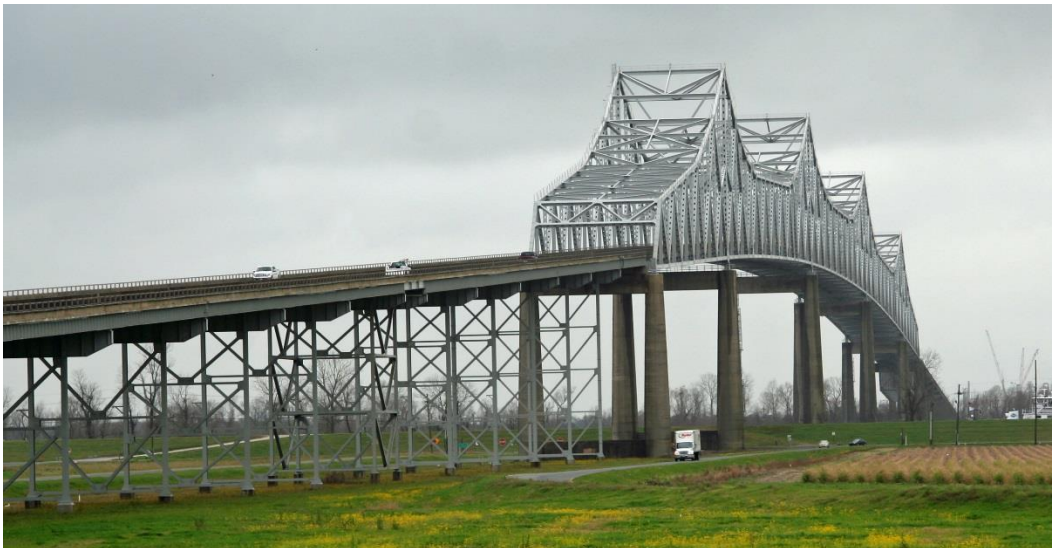
Condition Photo 18: Overall view of bridge looking west.

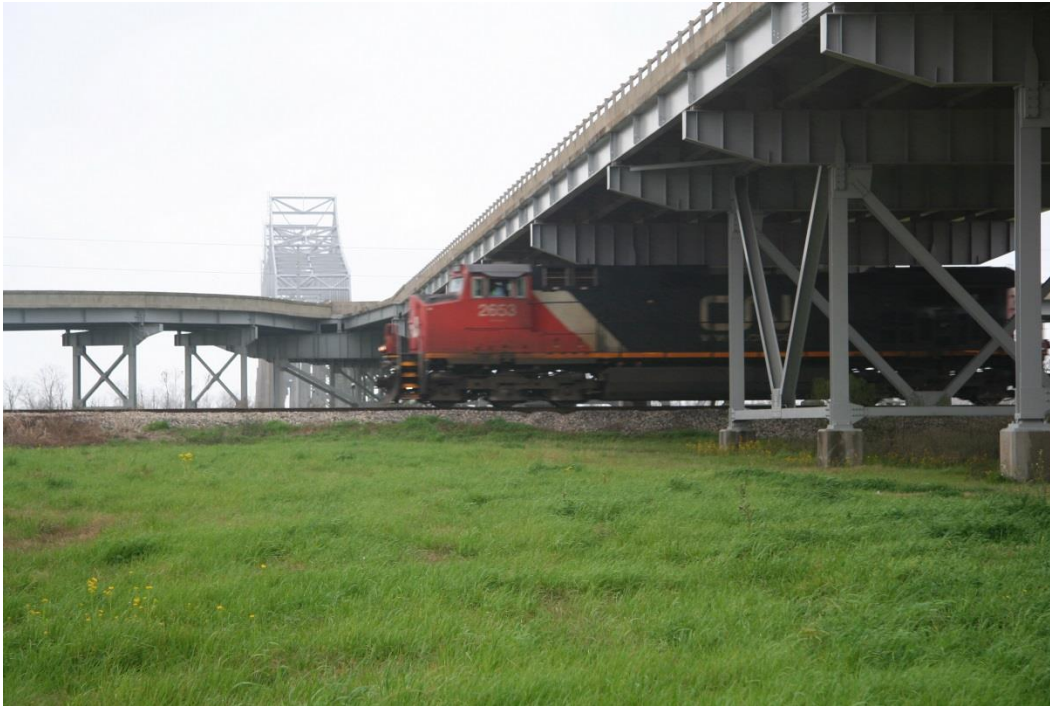
Condition Photo 19: Easterly approach span over the CNRR, with Y-split in background.
