Technical Manual for Dam Owners

Impacts of Plants on Earthen Dams

FEMA 534 / September 2005

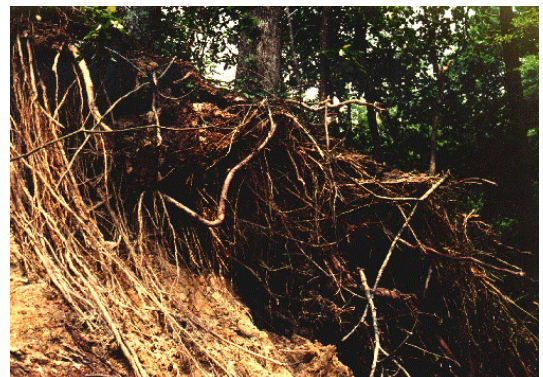
Figure 8. Exposed tree roots in overtopped dam.

Twenty-nine states indicated documented evidence where vegetation on dams has either caused dam failure or negatively affected their safe operation. Sixteen states had no documented evidence and five states had no response. Several states provided photos (Figure 8) and information on tree caused failures or dam

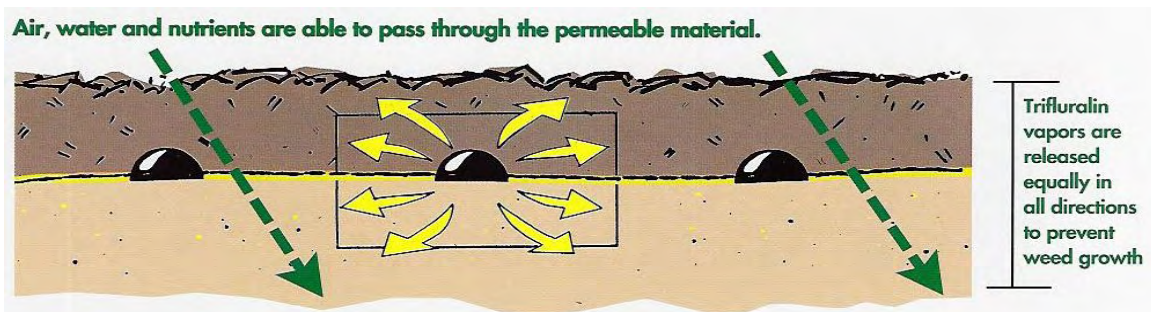
Figure 1. Chemical biocide barrier installation showing slow-releasing biocide nodules attached in a woven fabric matrix and installed under a cover of soil, mulch, gravel or stone (Biobarrier©).

One typical biocide product, called “Biobarrier©” is marketed and promoted, among other applications such as sidewalk and landfill cap protection, to prevent tree and plant roots from penetrating dams. The product consists of long-term, slow release nodules containing Trifluralin herbicide, that are bonded to a geotextile fabric as shown in Figure 1.

This particular barrier is environmentally acceptable to EPA and indicated to be effective against all types of roots around pipes, hardscapes, and dams and levees. While the product is guaranteed for 15 years, its life is inversely proportional to environmental temperature conditions.

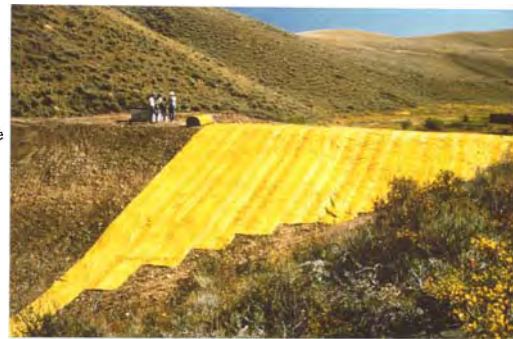
Figure 3. Installed chemical barrier on a dam in Montana (Kershner, 1992)

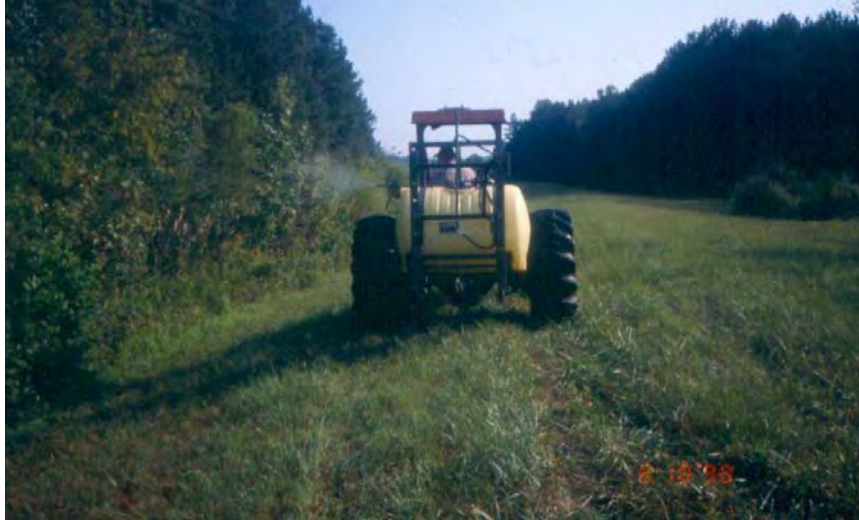
Figure 5f. Tractor spraying application on dam.

Some of these techniques and herbicides used are illustrated in Figures 5a – 5f. The U. S. Department of Agriculture (SCS, now NRCS) published a useful methods, treatment points, and time of treatment guidelines for controlling trees and brush on dams, including some of the applications listed in Figure 4 (USDA, 1988). Table 4 summarizes the USDA recommendations. With the exception of Krenite, which is applied to the foliage, 2,4-D is the only approved herbicide for poisoning trees on dams. 2, 4-D is manufactured by several companies and is sold under several trade names. In all cases, the user is cautioned again to follow the manufacturer's instructions and should consider the manufacturer's label instructions to supercede recommended instructions in the USDA table.

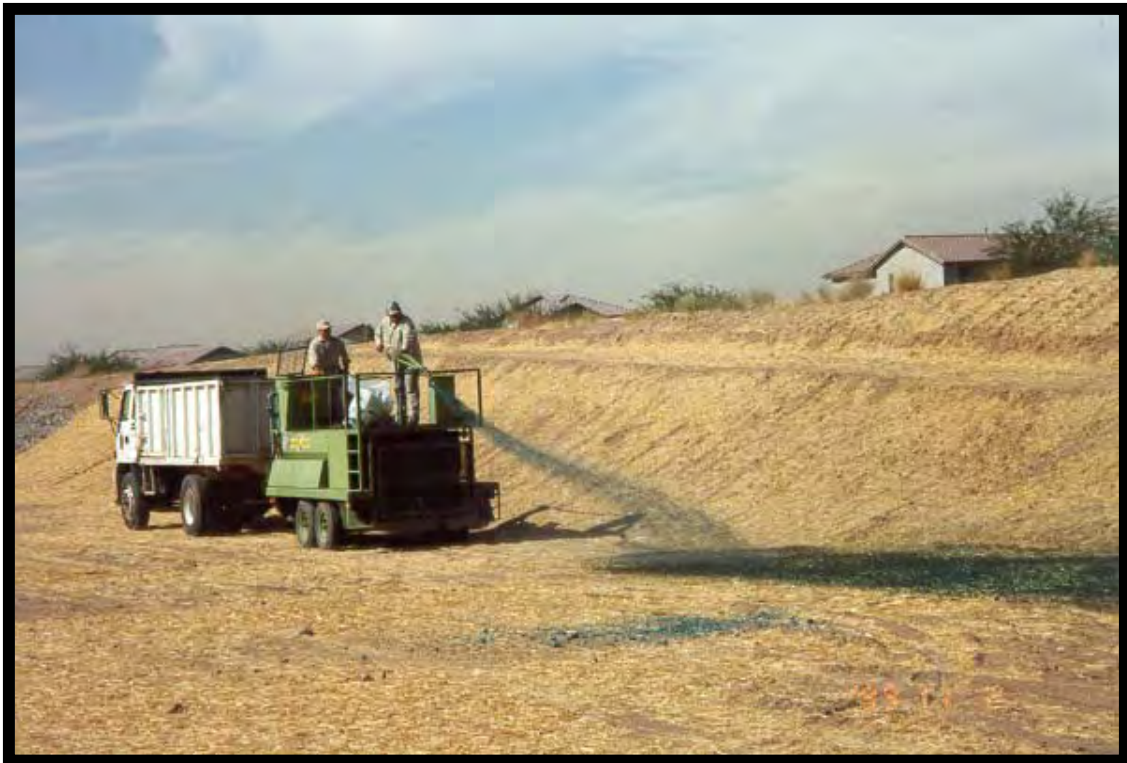
Figure 8. Hydro-seeding operations on a floodway dam in Maricopa County, Arizona (Renckly & Drake, 1999).

Revegetation on earthen dams is recommended to minimize erosion on the embankment slopes and to provide natural landscaping for earthen dams. MCFCD recommends hydro-seeding over labor-intensive hand-seeding to revegetate dam embankments. Figure 8 illustrates hydro-seeding operations on a floodway dam. Seed, water, tack material and a wood fiber or paper mulch are mixed in a hydro-seeder and sprayed directed onto the slopes. The seeds are encapsulated in the mulch and tack material until enough moisture is present to begin the germination process.

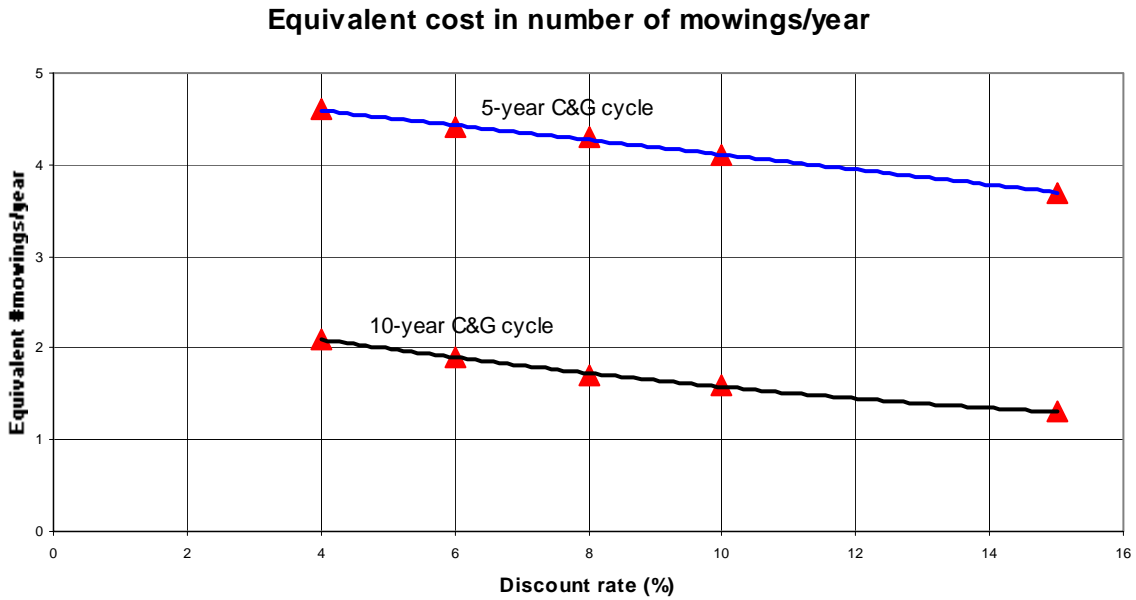
For a more conservative 5-year tree growth cycle and a \$2500 clearing and grubbing cost assumption, the annualized clearing and grubbing costs would be \$1523, \$1464, \$1406, \$1351, and \$1224 for the same discount rates, respectively. The corresponding justifiable mowings would be 4.6, 4.4, 4.3, 4.1, and 3.7 per year. Similarly, justifiable mowings for an assumed \$5000 clearing and grubbing cost would double the justifiable mowings to 9.2, 8.9, 8.6, 8.2, and 7.4 per year. Figure 4 compares 5 and 10-year annualized costs for \$2500/acre clearing and grubbing payouts.

Figure 4. Comparison of Annual Tree Clearing and Grubbing Costs for 5 and 10-Year \$2500/acre payouts.

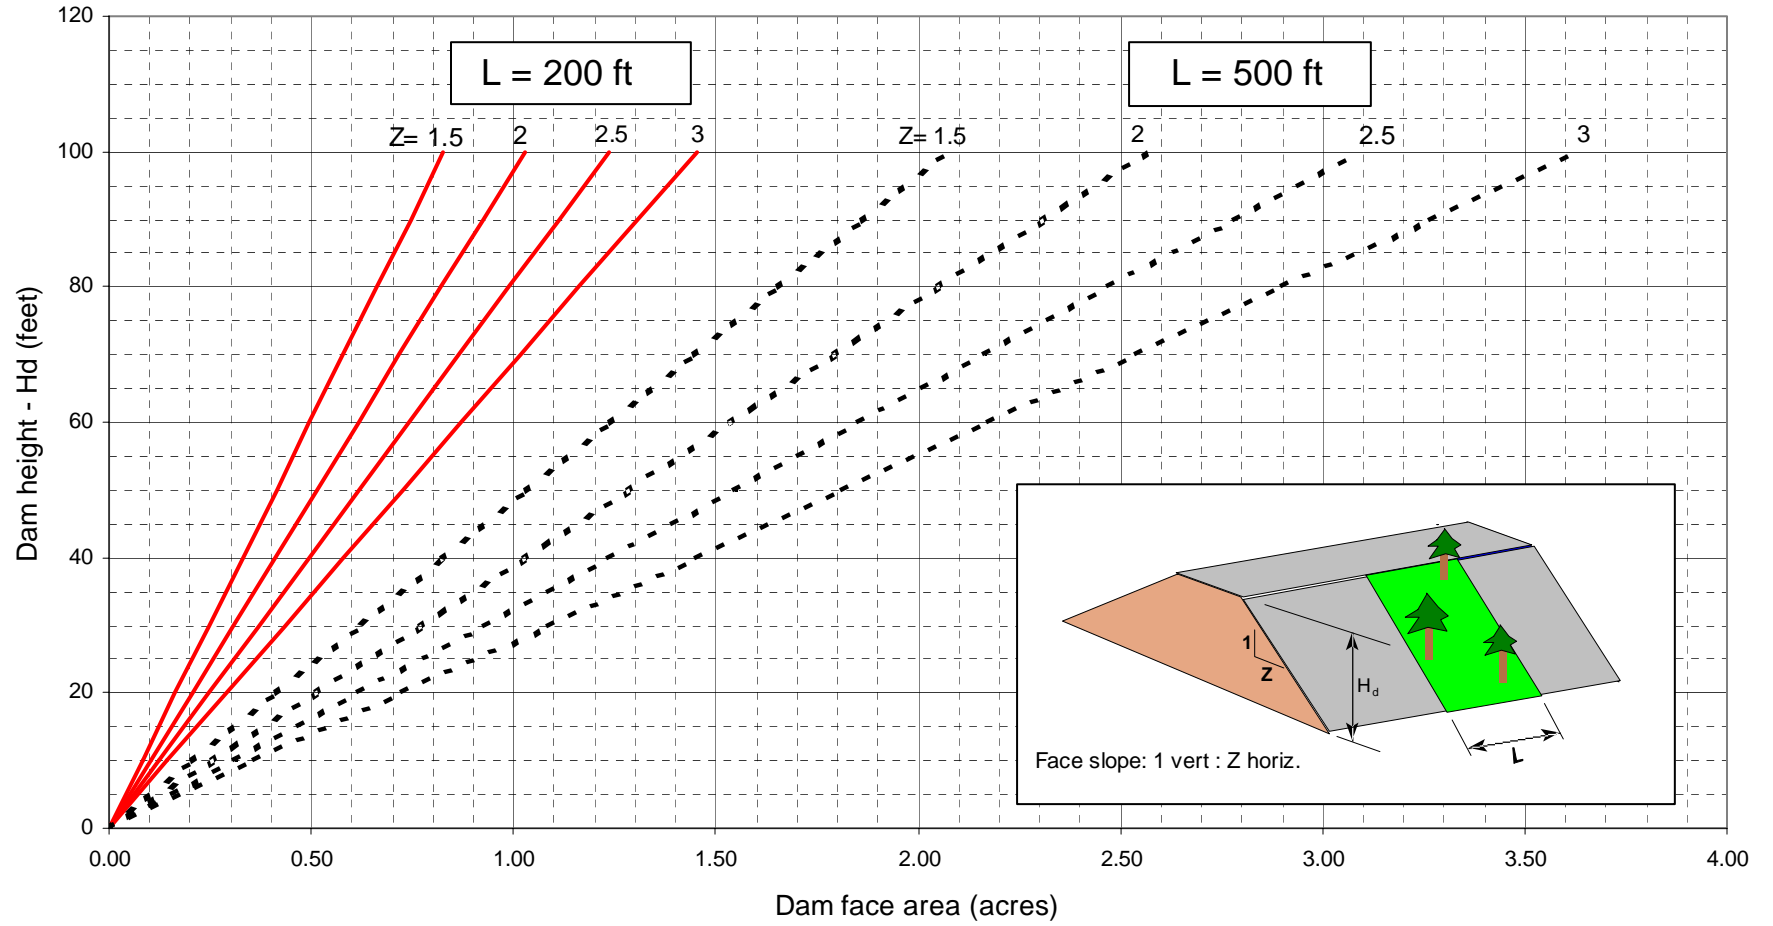
Chart 1. Dam face area for different geometries

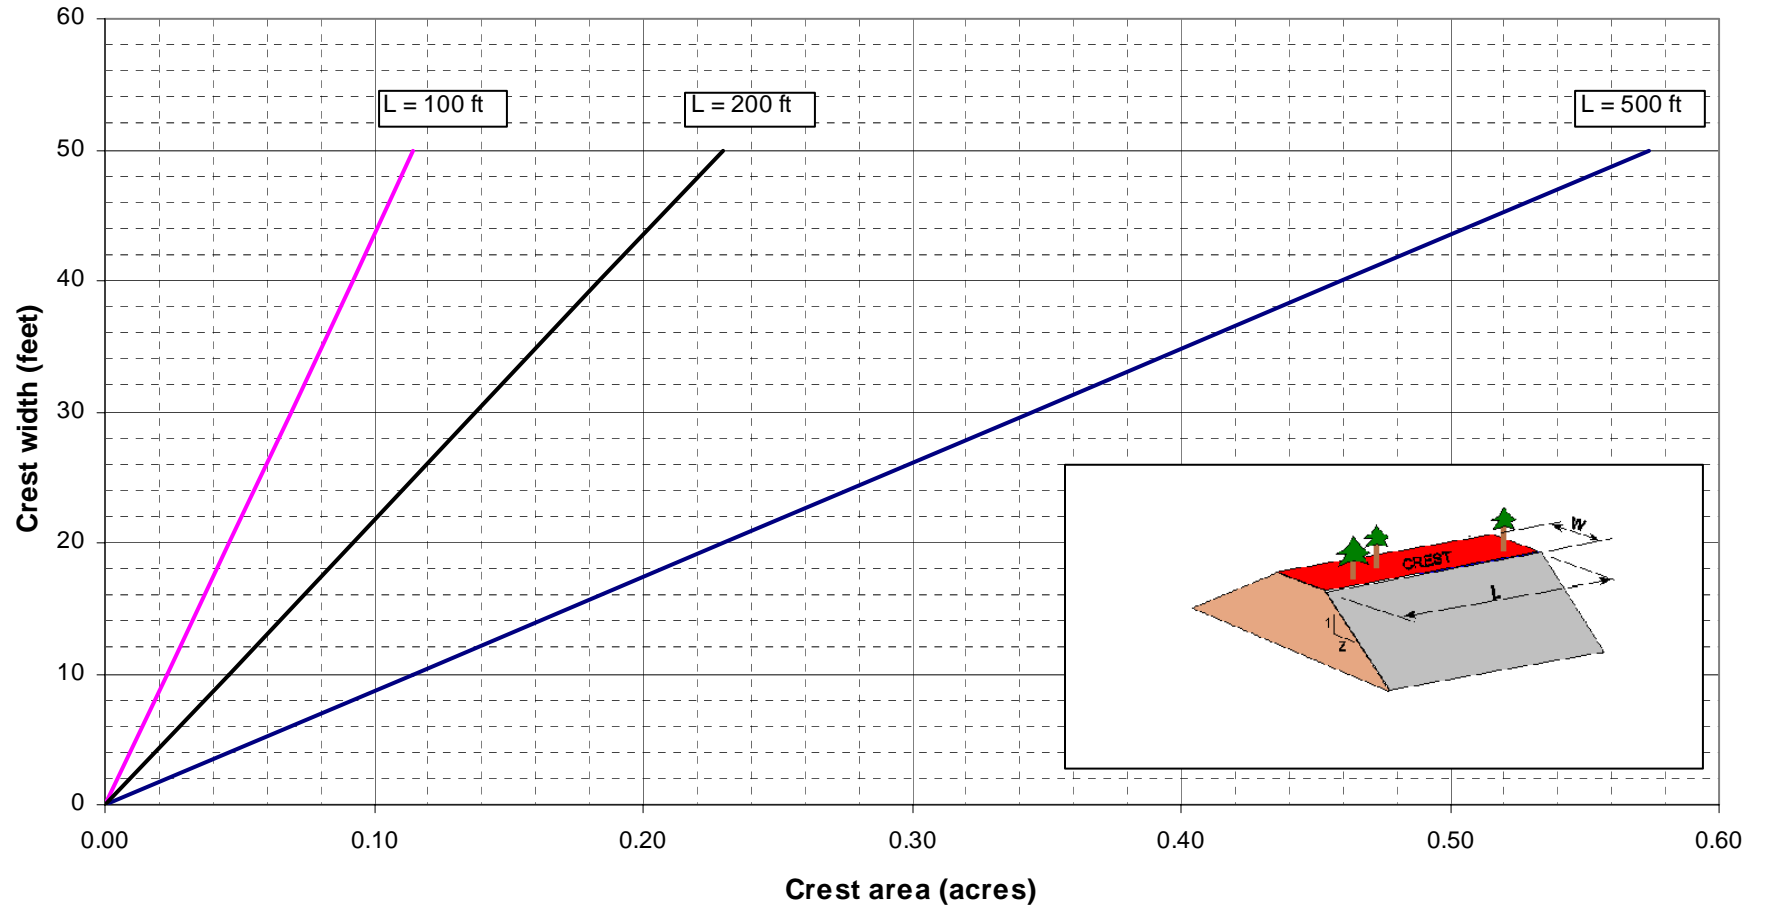
Chart 2. Dam crest area by width and length
